## State Preservation Board

### Texas Capitol Roof Replacement and Rehabilitation Update 5/5/2025

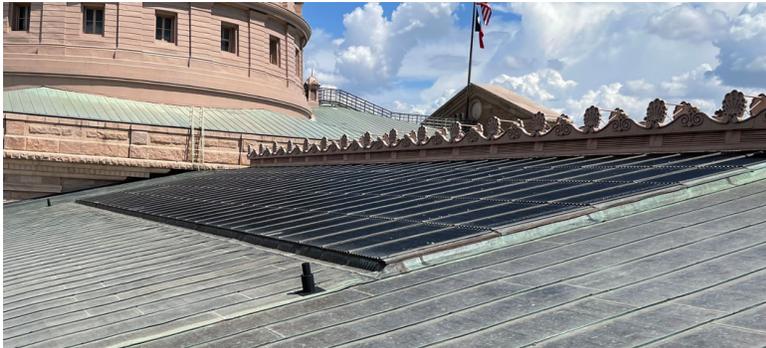
IMG\_1117.jpg

The east and west skylights are fully replaced. Viewed from above, the skylights better replicate their historic appearance. Original 1888 curbs had been roofed over in 1949, and both those curbs roofed over again in 1993, resulting in a built-up condition and a “turned” appearance which reduced their visual height. The new, cleanly detailed curb replicates the original appearance with modern systems and will keep this leak-prone area watertight.

1993 curb with 1949 cant

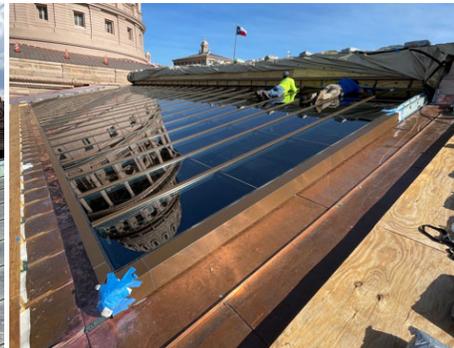
IMG\_8627.JPG

2025 curb

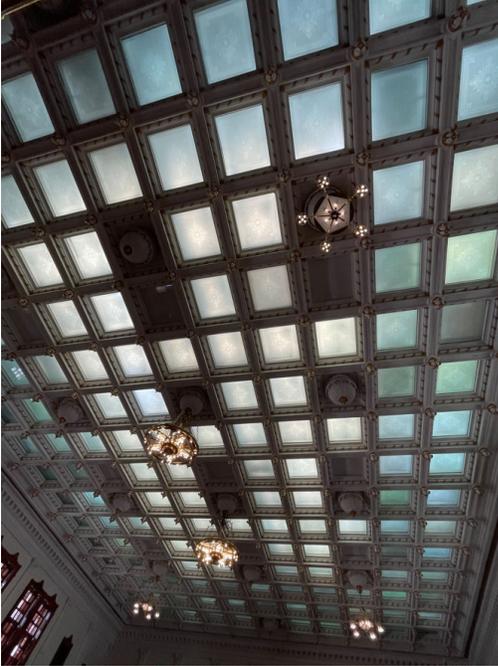
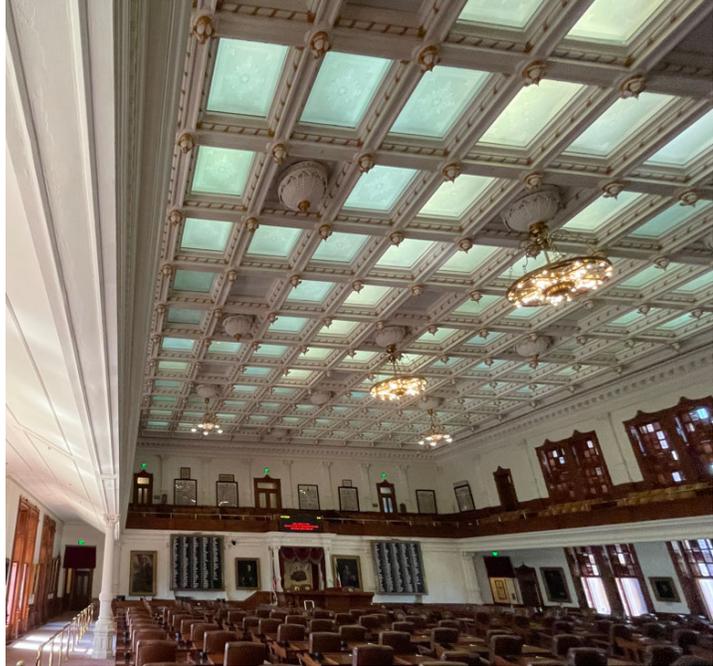
Previous appearance on a sunny day, lights on 100%:

The new LED lighting system at the laylight glass chamber ceilings below the skylight replaced the circa 1995 gymnasium-style metal halide lighting, offering higher light levels, reduced maintenance and energy costs, reducing heat loads in the attic, and providing dimming and light color control to the chambers below. The transparent LED light allows through 90% of daylight and full visibility, allowing the ceiling to range from a completely original historic appearance (naturally sunlit with no artificial light except the 1890 electroliers), to fully lit to modern office standards for working conditions into the evening during late night legislative sessions.

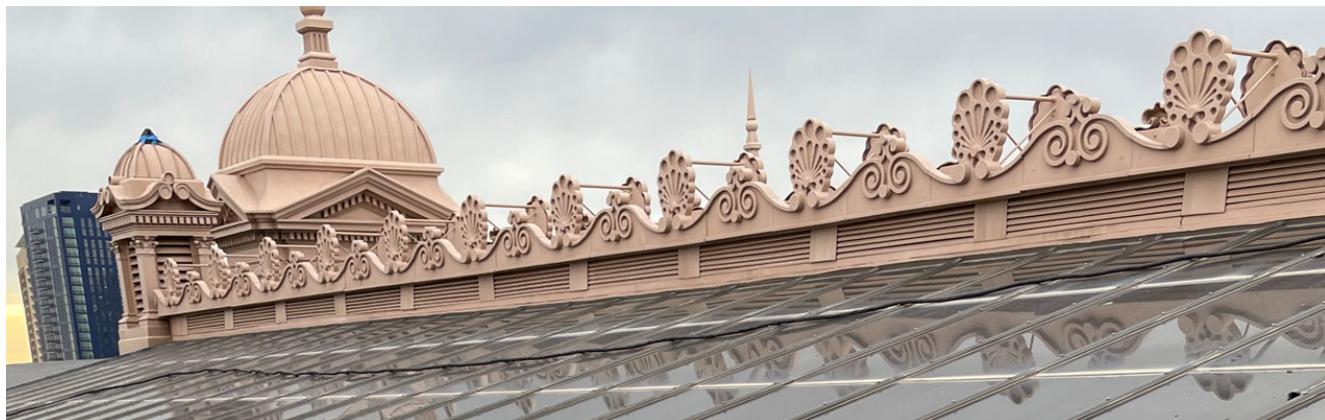
IMG\_0571.JPG

The skylight ridge vents were improved to prevent wind-blown rain and dust from entering the attics, previously a major source of water intrusion. They were carefully detailed with screens to keep out crickets during their annual September invasion, as well as carpet beetles and their damaging impacts to the reproduction wool carpets in the chambers below. It also reduces the visual appearance of the non-original raised height of the reproduced ridge cresting detail.

1995 detail:

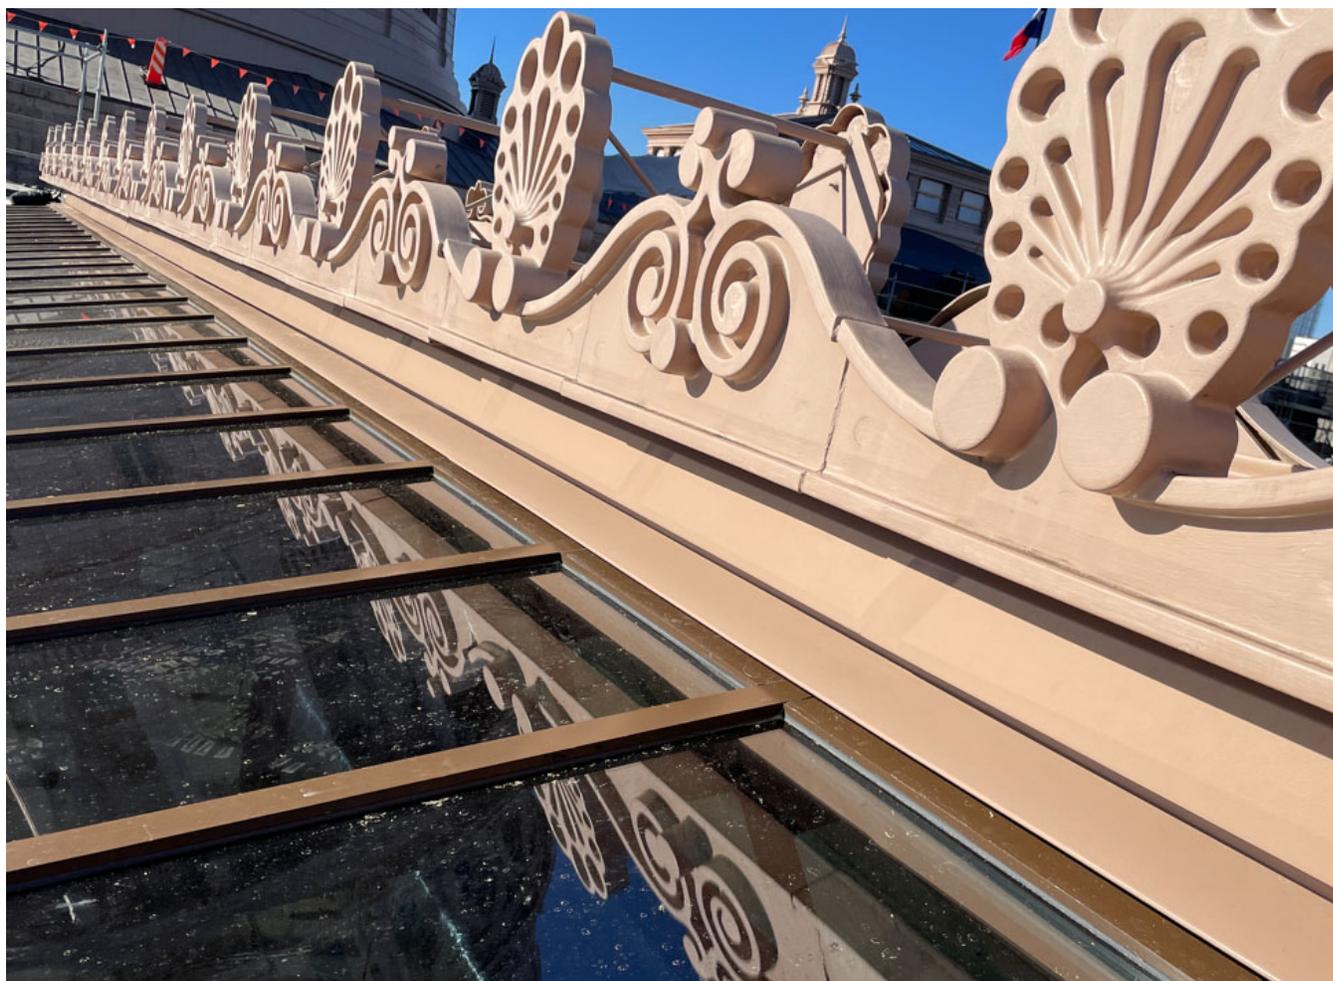
IMG\_5569.JPG

New detail:

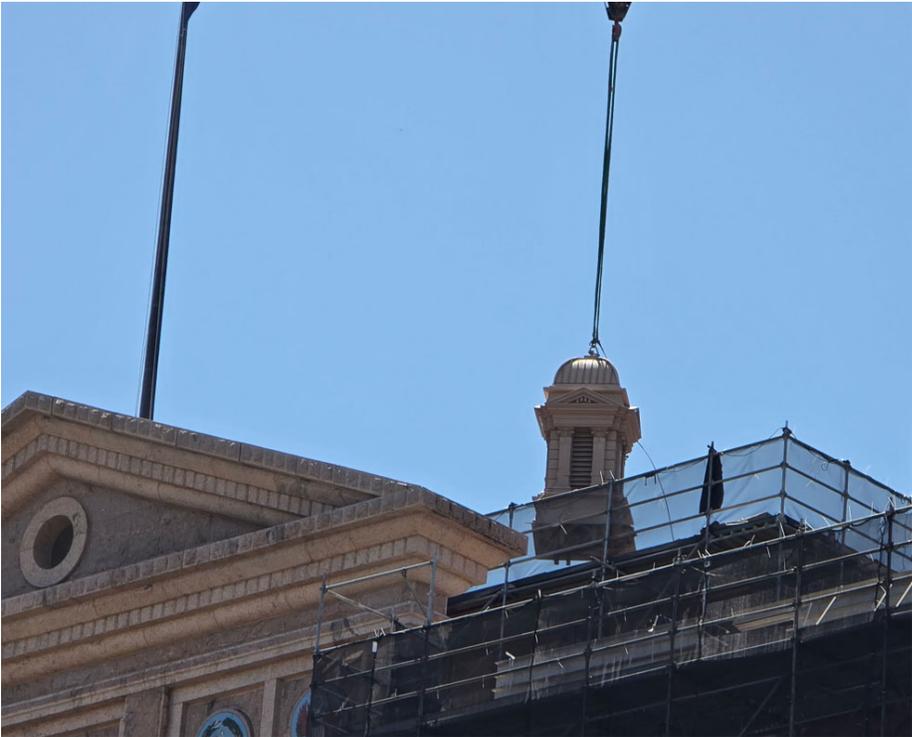
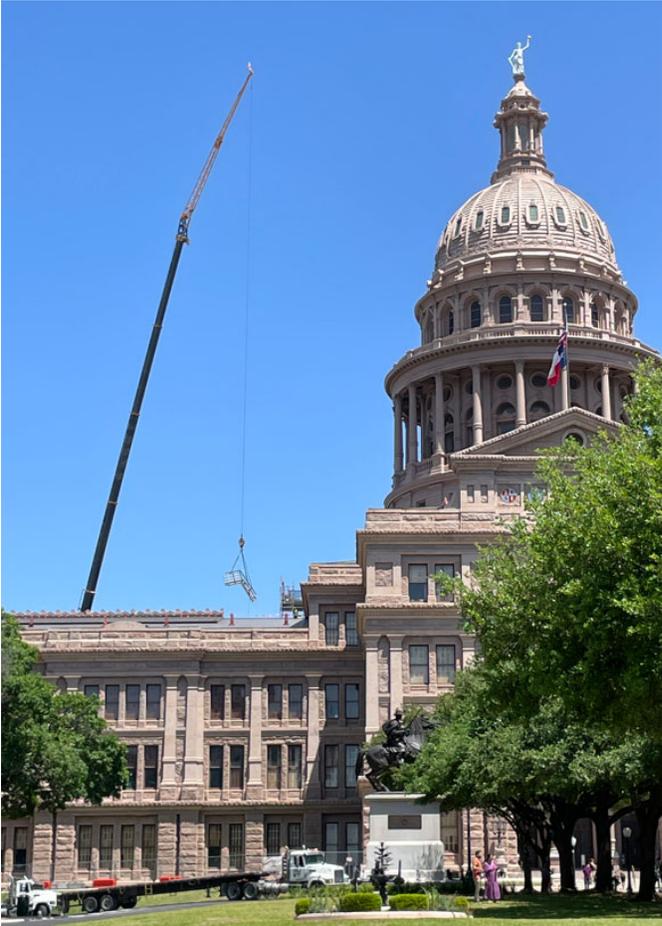
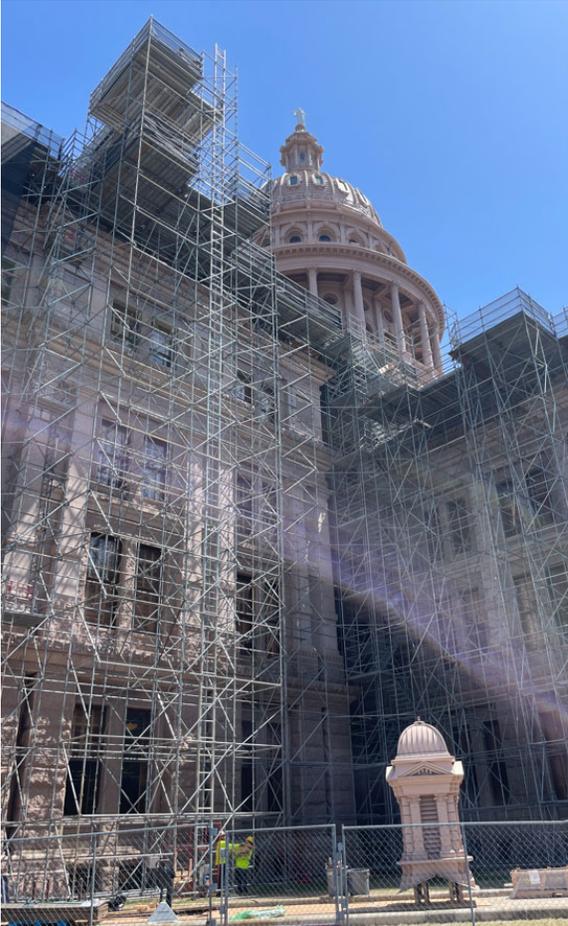
A very tall crane was required to lift the 15 foot tall, ca. 1993 reproduction ventilator off the top of the lantern, required to replace the skylight. It was tested and confirmed to leak in several areas, and will be repaired before being re-placed.

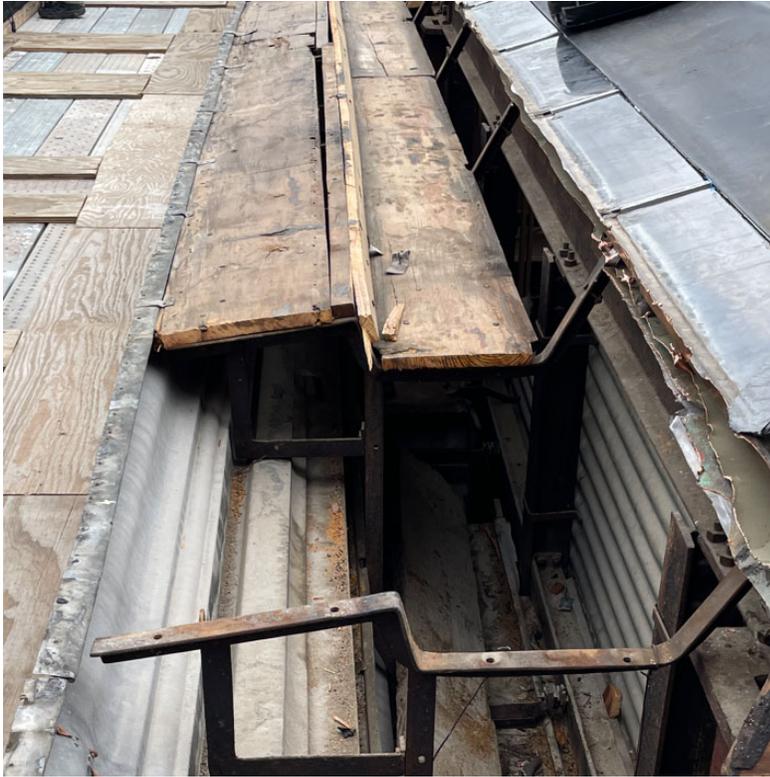
IMG\_0124.JPG

We are replacing split, rotted, patched, and poorly attached 1888 gutter blocking to improve wind resistance at this wind-prone area.
