Texas Capitol Roof Replacement and Rehabilitation

Project Update, 1/20/2023

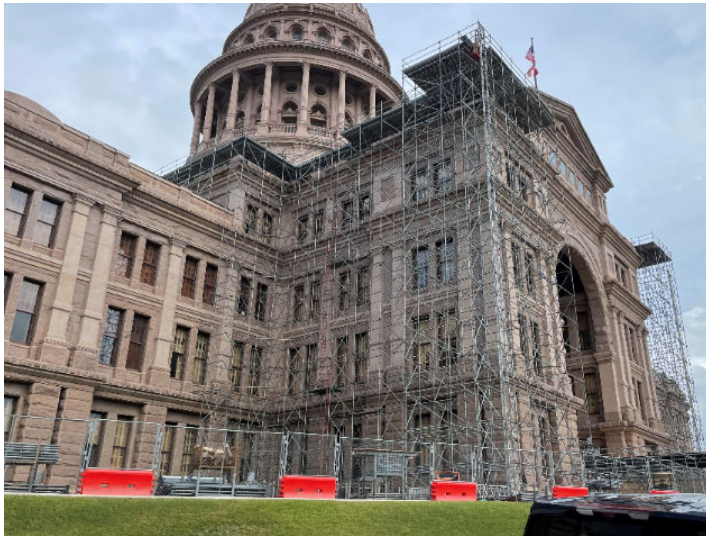
The south wing has been fully scaffolded. The north side of the east wing has been scaffolded, and now that we are in session, the south side of the east wing will continue between the hours of 7 pm to 7 am. The scaffolding is light in appearance, because it only is intended to provide fall protection at the edges of the roof, and a platform for workers to reach the gutters.

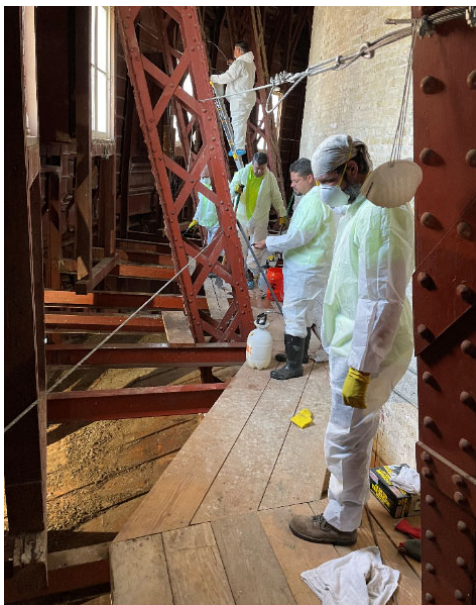
The dome interior has been cleared of 200 bags of trash and pigeon guano, safely removed, and the space cleaned thoroughly.

Decking is being added to this space for improved access safety, and to support scaffolding to access masonry vaults overhead, for repointing.

Openings in the dome will be sealed to prevent pigeon infiltration, they are finding their way in through remarkably small openings.

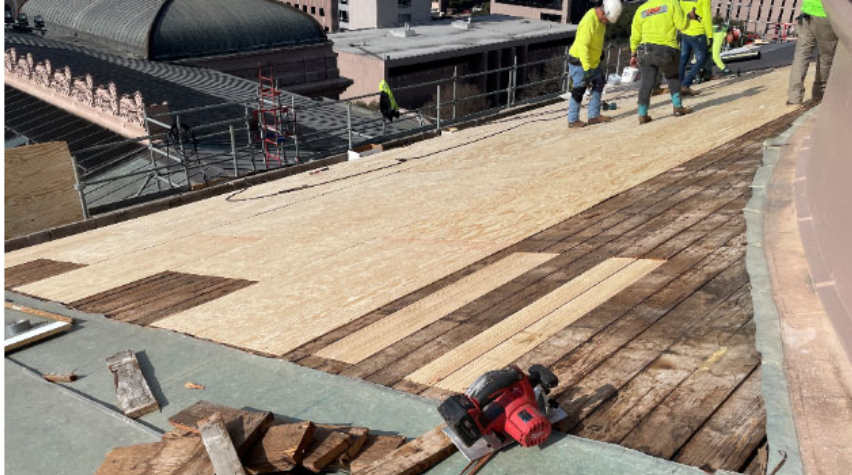
The 1949 and 1992 copper roofing is being removed and recycled by a facility selected based on highest price offered. All copper roofing not retained by the State is being recycled; there is no direct sale to the public planned as a reclaimed material.

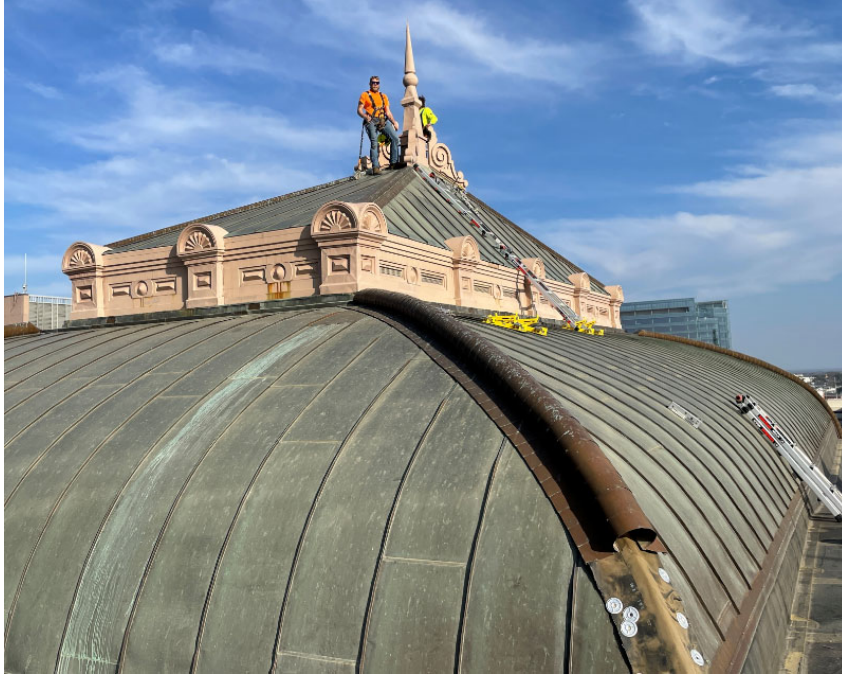
Gutter carpentry is underway, being built into the gutter carved into the top block of granite.

The gutter metal will be installed starting in early February. By mid February, shiny new copper will be placed on the roof, to the west of the dome.

Details of the gutter were considered to ensure that water never backs up onto the roof, and that we maximize the 1888 downspouts to bring water off the roof. We are constructing as strong a roof as feasible, with strong and frequent connection points. Older corrosive fasteners are being sealed to prevent rust.
