State Preservation Board

Texas Capitol Roof Replacement and Rehabilitation Update 12/13/2023

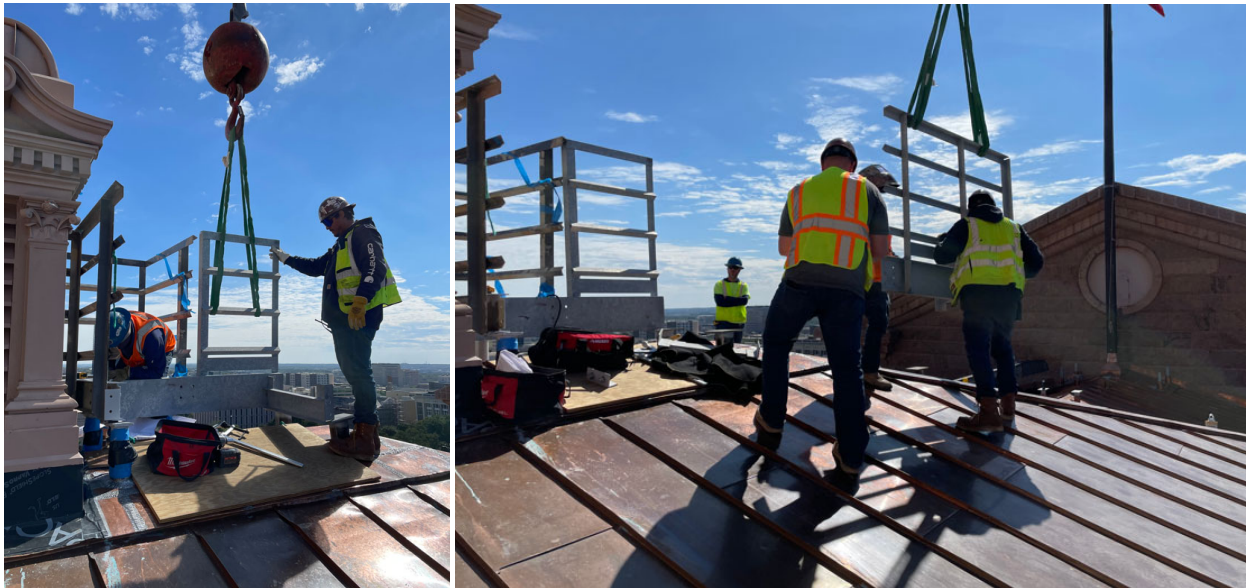
The new catwalk to the south pediment flagpole was flown into place by crane.

It will have steps, rather than a ramp like the previous catwalk, for OSHA-compliant access for personnel flying flags. It will also provide safe access to the roof surface.

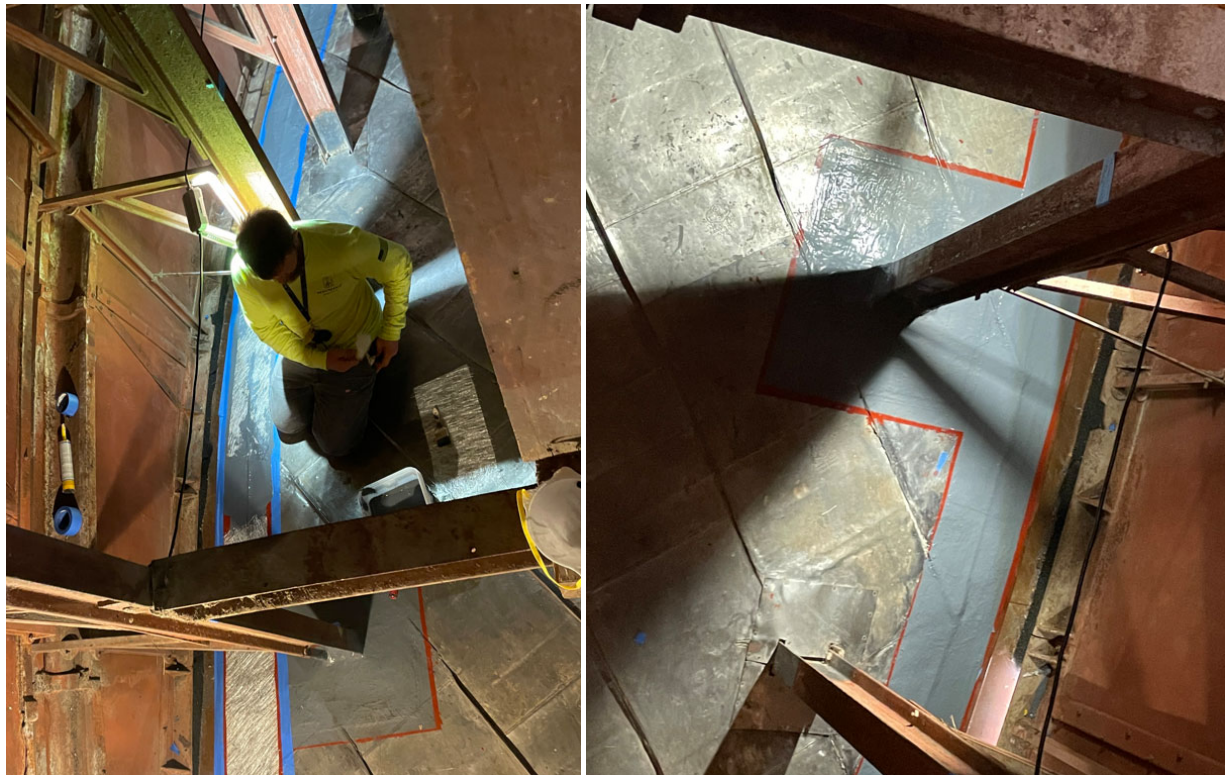
At the main roof level of the dome, a Cop-R-Loy roof remained in serviceable condition. The product history suggests it was placed sometime after 1928. It is described in project literature of the time as "refined ferrous metal made to a prescribed formula which includes special heat treatment and the alloying of pure ingot copper with the metal while it is in a molten state." To prevent having to replace this roof, and to address the unique configuration of a circular dome on a rectilinear roof, it is being tied into the new roof and sealed with modern materials.

Dome framing which penetrates this roof also creates difficult conditions to waterproof with traditional metal construction. They originally had "pitch pocket" waterproofing elements containing asbestos. These were abated and made safe, and the holes are being re-sealed with modern materials.

These materials are in protected locations and should have very long lives, protected from UV exposure, and are readily accessible for maintenance over time.

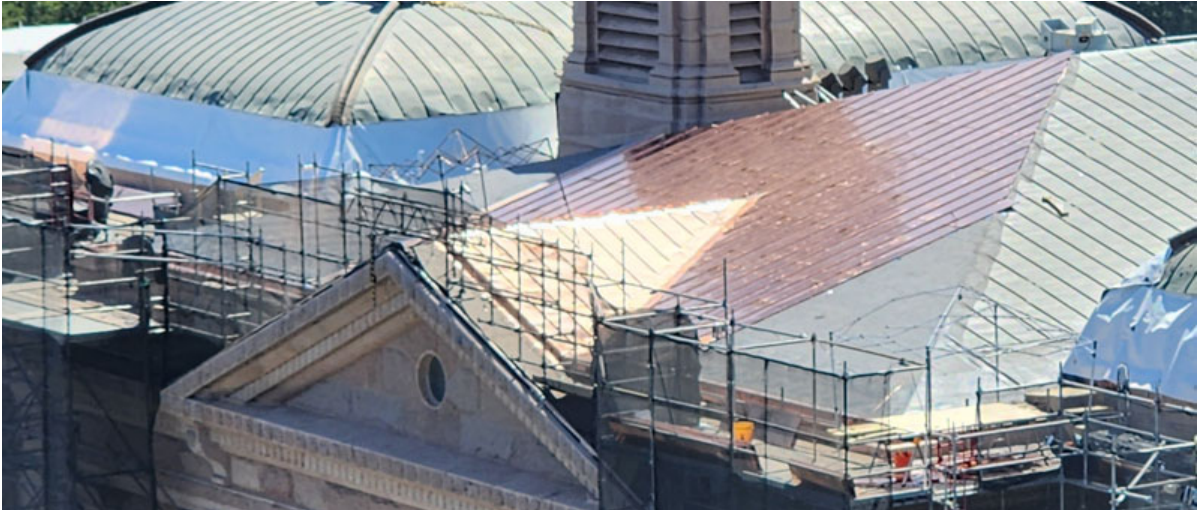
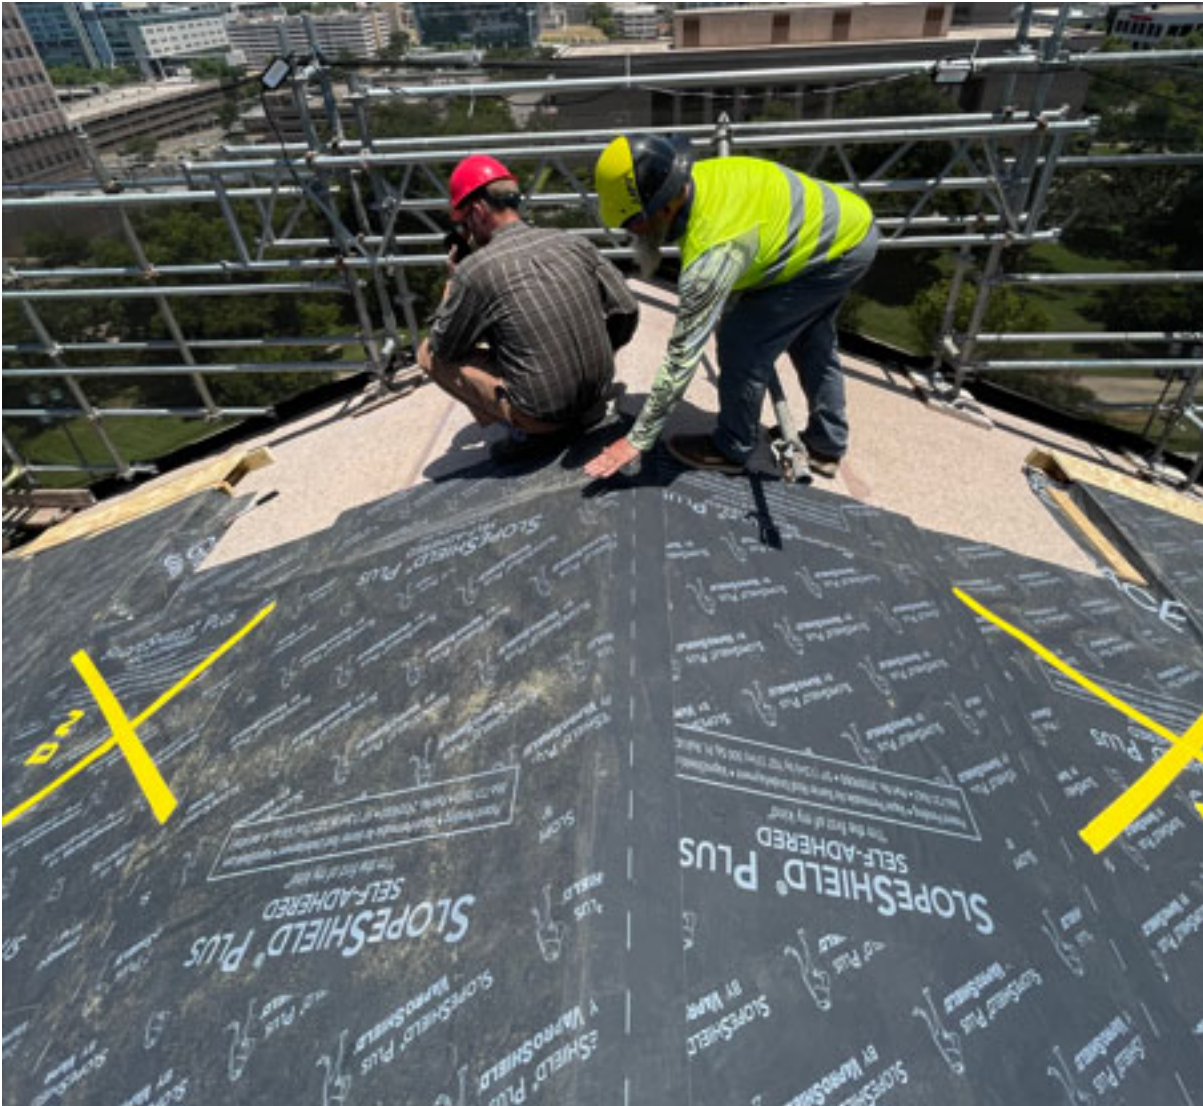
New standing seam roof is being installed over an improved cricket that protects the east pediment.

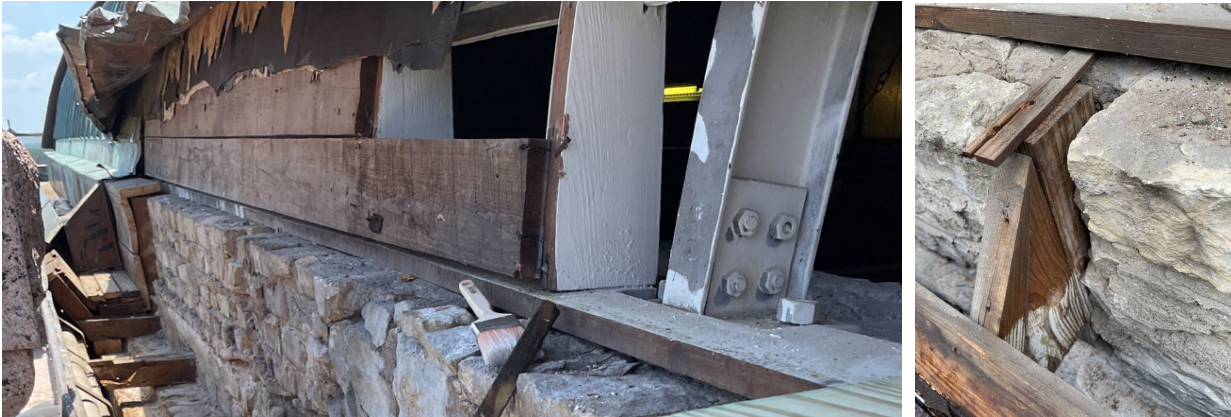
Original Framing

The four corner “pavilions” continue to be a focus of work. Their 1888 framing is being reinforced to improve uplift resistance of this roof, which previously was simply bolted into single stones within a roughly formed limestone wall, with gutter framing cast in. The new framing system ties the roof together mechanically and spreads out uplift forces along the entire upper wall, with additional connection points lower on the wall, gutters, and fascia below, creating a cohesive structural system.

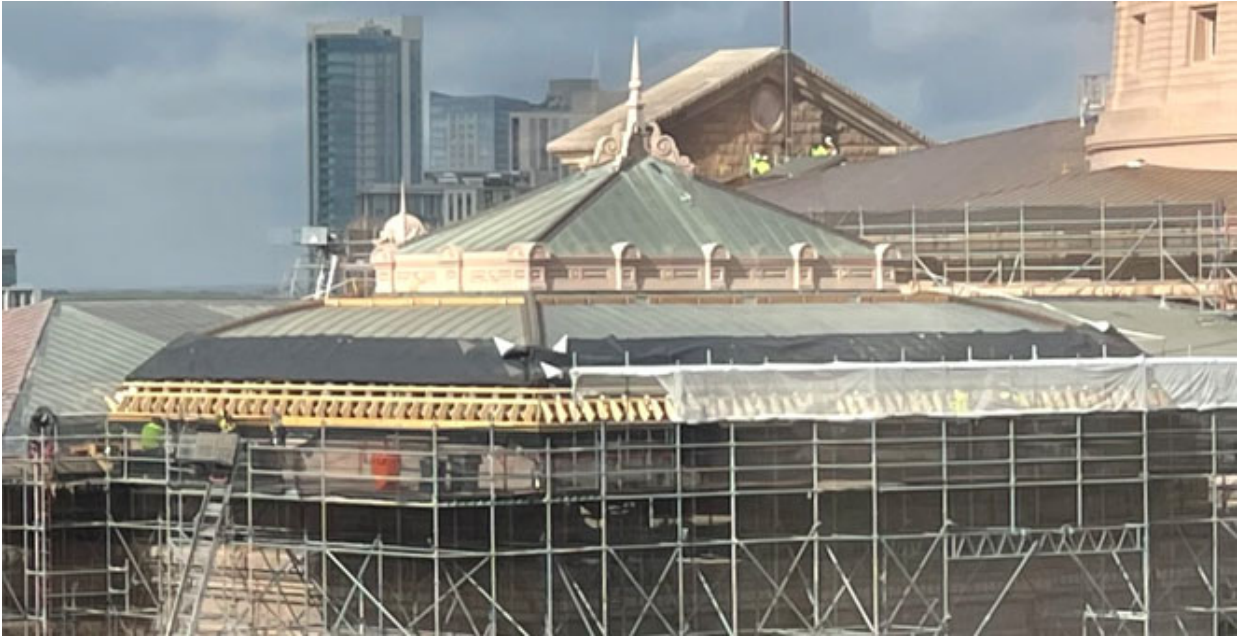
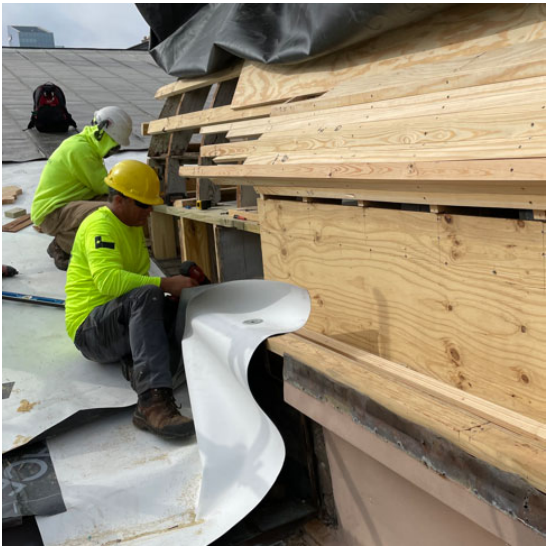
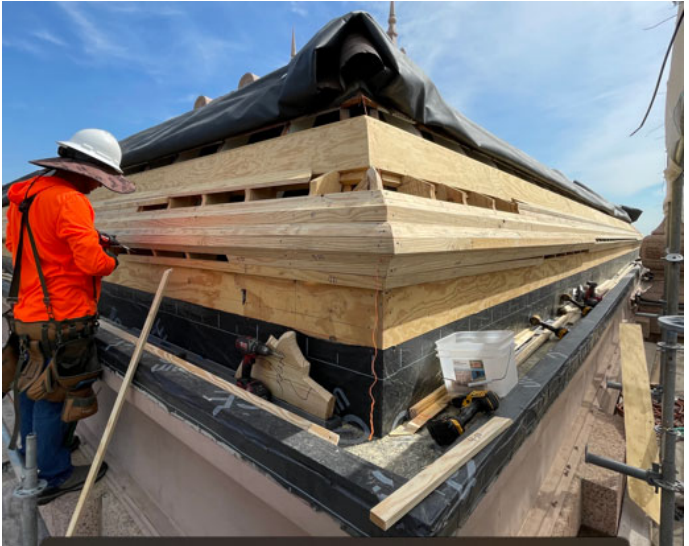
The decorative band around the base of the roof, which was discussed in the previous update, is part of this system of strengthening the roof as well as restoring an original design detail.

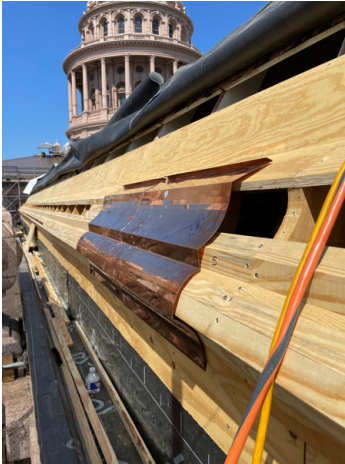
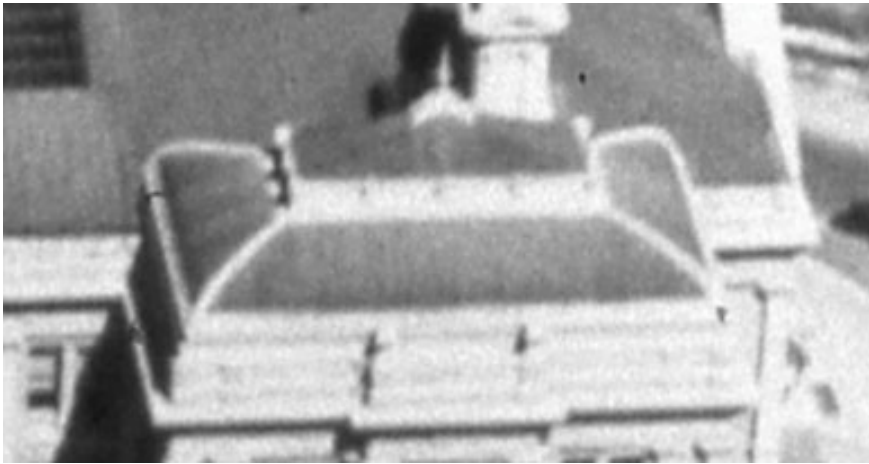
This element will be clad in copper for compatibility with roof above and gutter below, and for longevity, but will be painted to match the original design

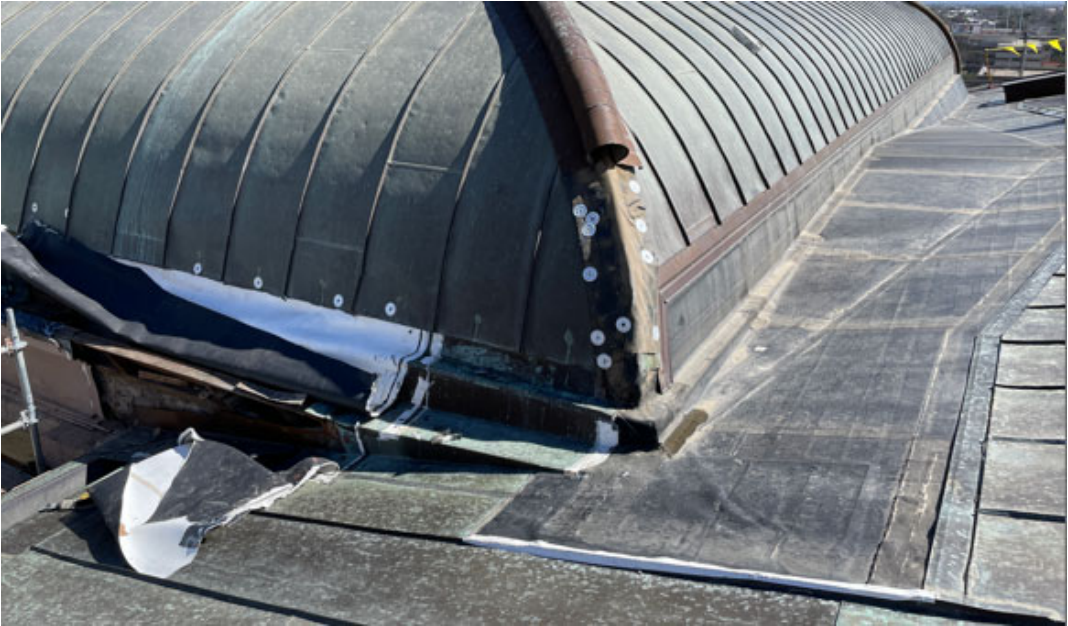
A difficult detail exists where the low-slope main roof meets the back of the steep-sloped mansard roof of the pavilions. It effectively creates a flat gutter on top of the roof, requiring water to flow around a corner before it can shed off the roof. This area has been leaking extensively in the past couple of years, including when snow accumulated in recent snow events, causing freeze damage and leaks.
