Old General Land Office Building/Capitol Visitors Center

Exterior Preservation and Roof Replacement

Project Update: 9-18-2023

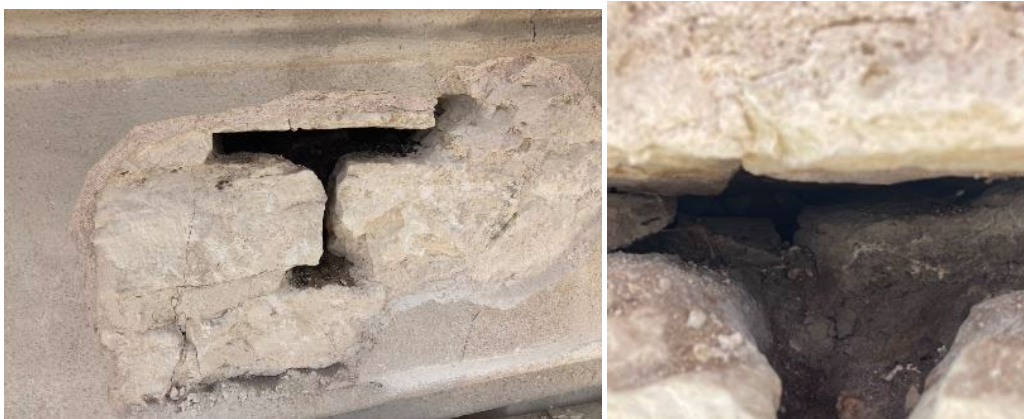
We have encountered a variety of different unique conditions on the building including severe mortar loss in the historic limestone walls, random bricks/dirt/rubble near exterior face, and even exposed timbers just $\frac{3}{4}$ " shy of the outside wall. We've found large 1'-2' voids in the 3' thick walls that were filled with large quantities of black dirt. We think this was a historic black clay used as a binder along with mortar during the original construction.

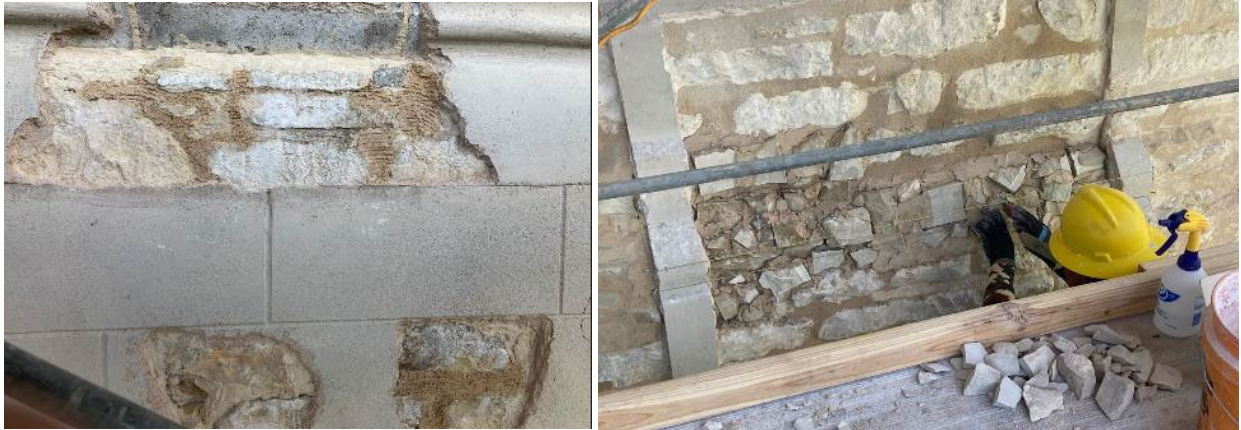
The workers use a variety of masonry repair techniques depending on what they encounter. Large irregular masonry joints that are cracking have to use *galleting*, a process of pushing small stones into large wet mortar joints to help balance the proportion of stone and mortar to reduce cracking.

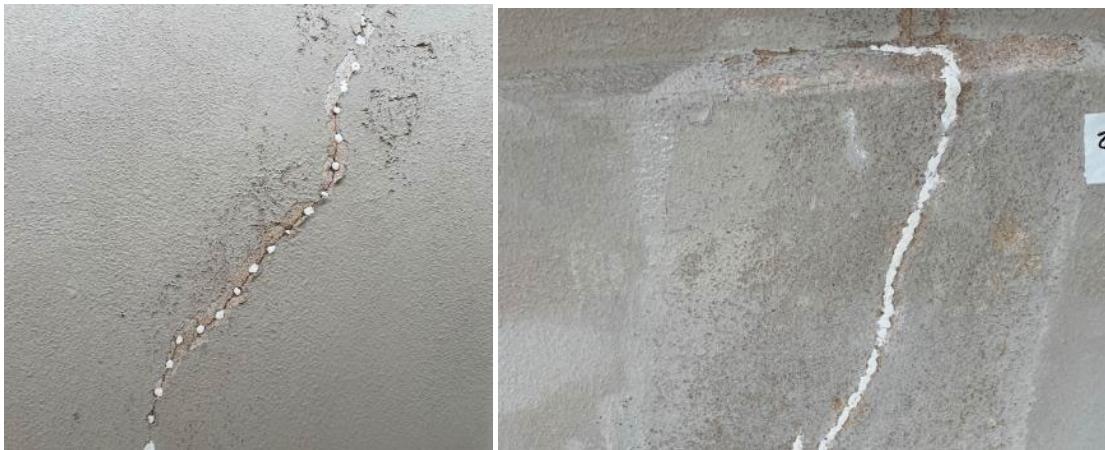
The masons are also using DHL Crack Injection for cracking in the walls that exceed 1mm in width. This is masonry technology that uses dispersed hydrated lime, a lime based putty formed as a concentrate in a lab centrifuge, injected with a syringe into small holes drilled every $\frac{3}{4}$ " for the length of the crack. The intent of the lime is to help bridge the crack, dissolving and re-depositing calcium crystals to fill any gaps created as the building continues to move with changes in the exterior environment and underlying substrate.

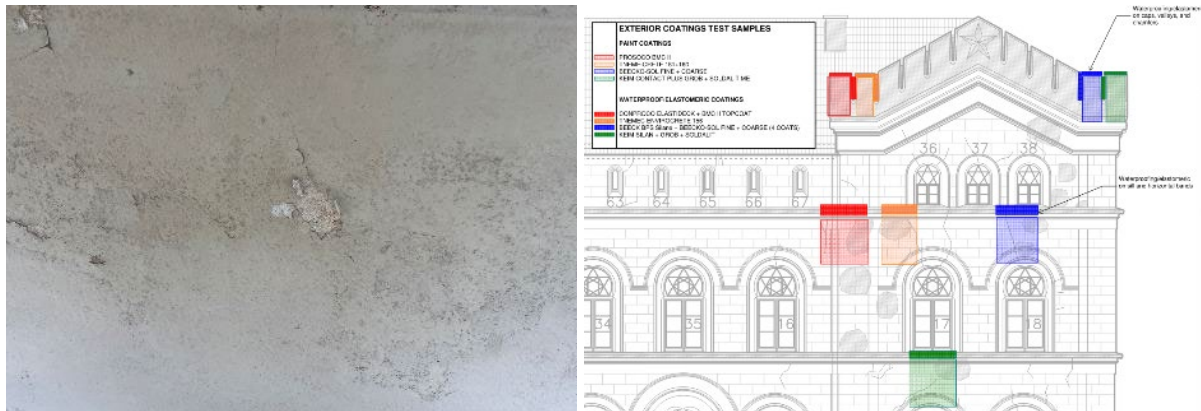
We decided to use a highly durable and impact/uv resistant elastideck on the projecting horizontal courses at each floor and the skyward facing surfaces of the character defining crenellations, to protect against rainfall, running water and hail, in these locations which had shown the most stucco deterioration since the 1993 building restoration.

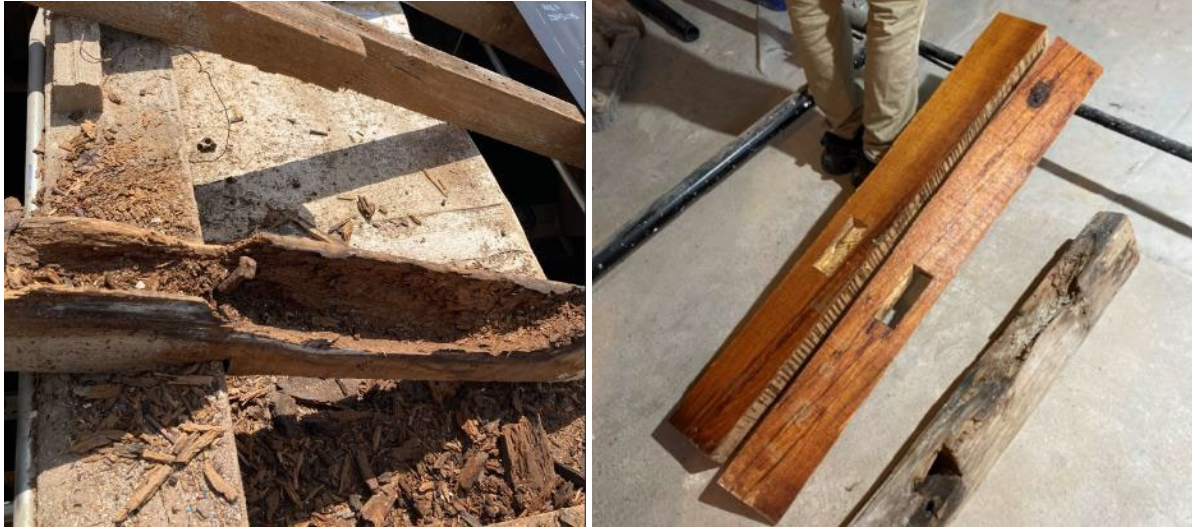
The slate roof has been showing signs of leaks since the 1990's. Several areas along the edge of the roof near the downspouts and the chimneys have evidence of leaks that have damaged the historic 1850's underlying timber structural elements.

Four locations and types of repairs were used to rehabilitate the historic timber structure. In the areas where replacement was necessary we provided old growth yellow pine as a complementary in-kind material. For larger members the contractor had to laminate smaller members together to achieve the desired matching profile for replacement.

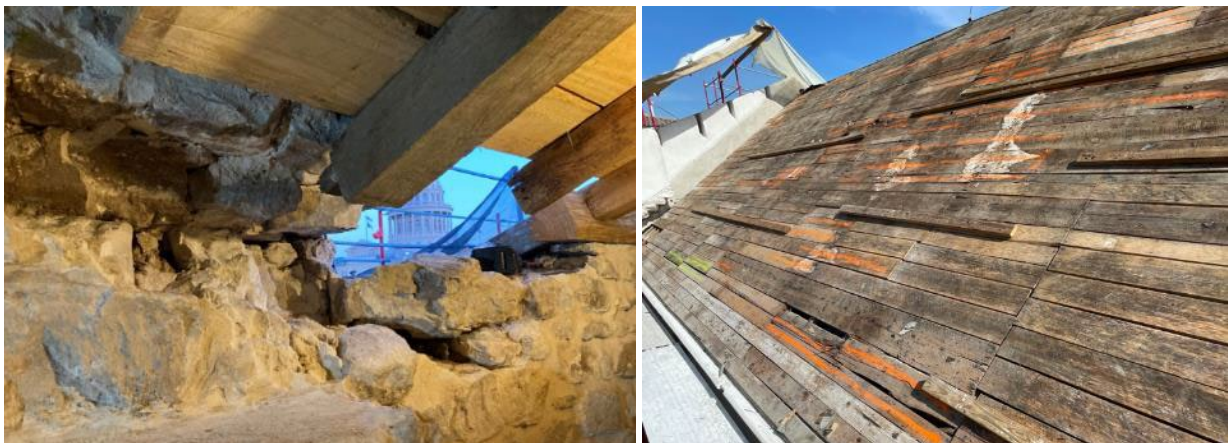
Water damaged or splitting historic wood decking was replaced with old growth lumber sourced from a North Carolina mill.

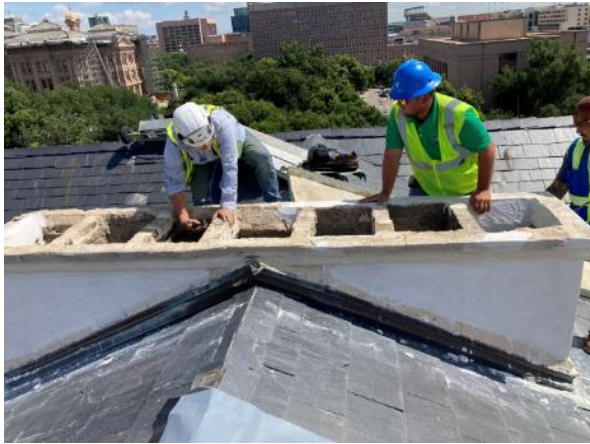
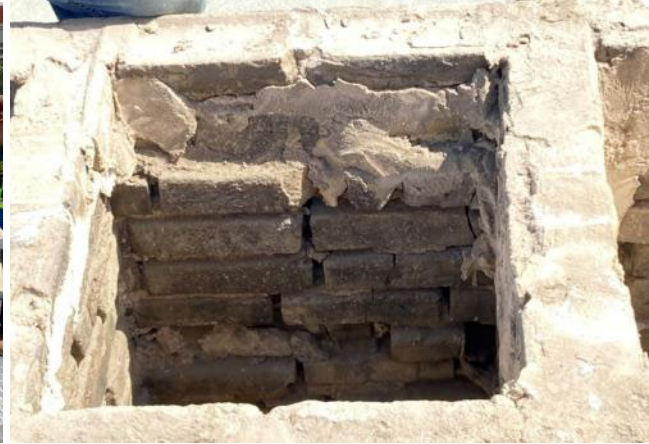
We've also been able to survey the existing single wythe historic brick chimneys. This work provides rare access to the interior of the chimneys; the contractor was able to repoint and repair some of the deteriorating joints.
