**Old General Land Office Building/Capitol Visitors Center
Exterior Preservation and Roof Replacement
Project Update: 4-15-2024**

BEFORE - Existing typical conditions prior to the exterior preservation and roof replacement

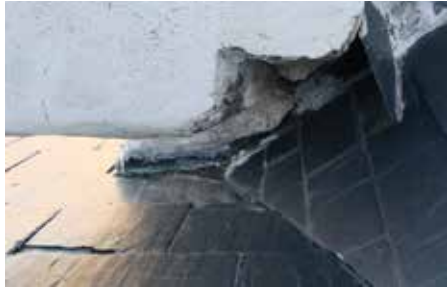
Poor flashing details at the roof/parapet intersection.

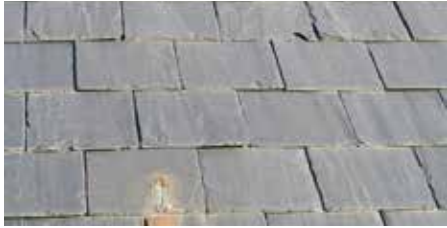
Broken slates and poor slate quality

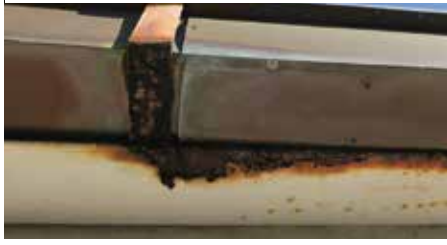
Corroding and failing gutter supports from the non-historic box gutters.

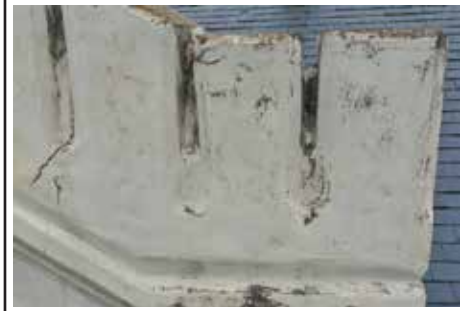
Cracking, loss, and biological growth.

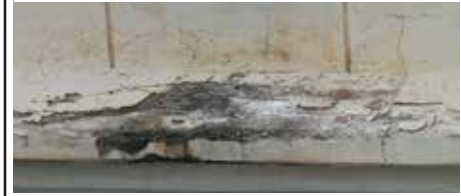
Stucco loss from water intrusion

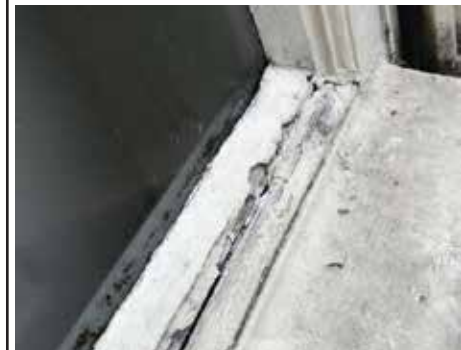
Window glazing and sealant failure

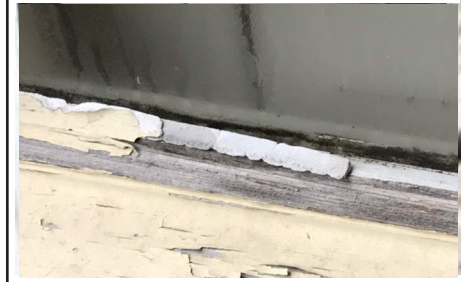
Paint Peeling and deterioration to exposed wood window elements.

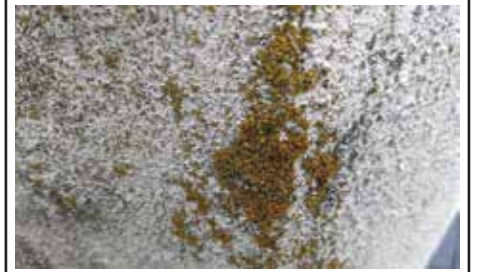
Biological growth

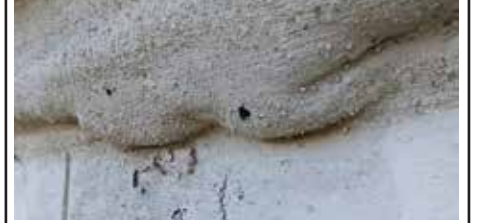
Improper paint application retaining water

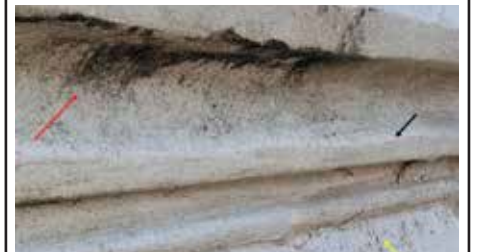
Paint staining and failure from water intrusion

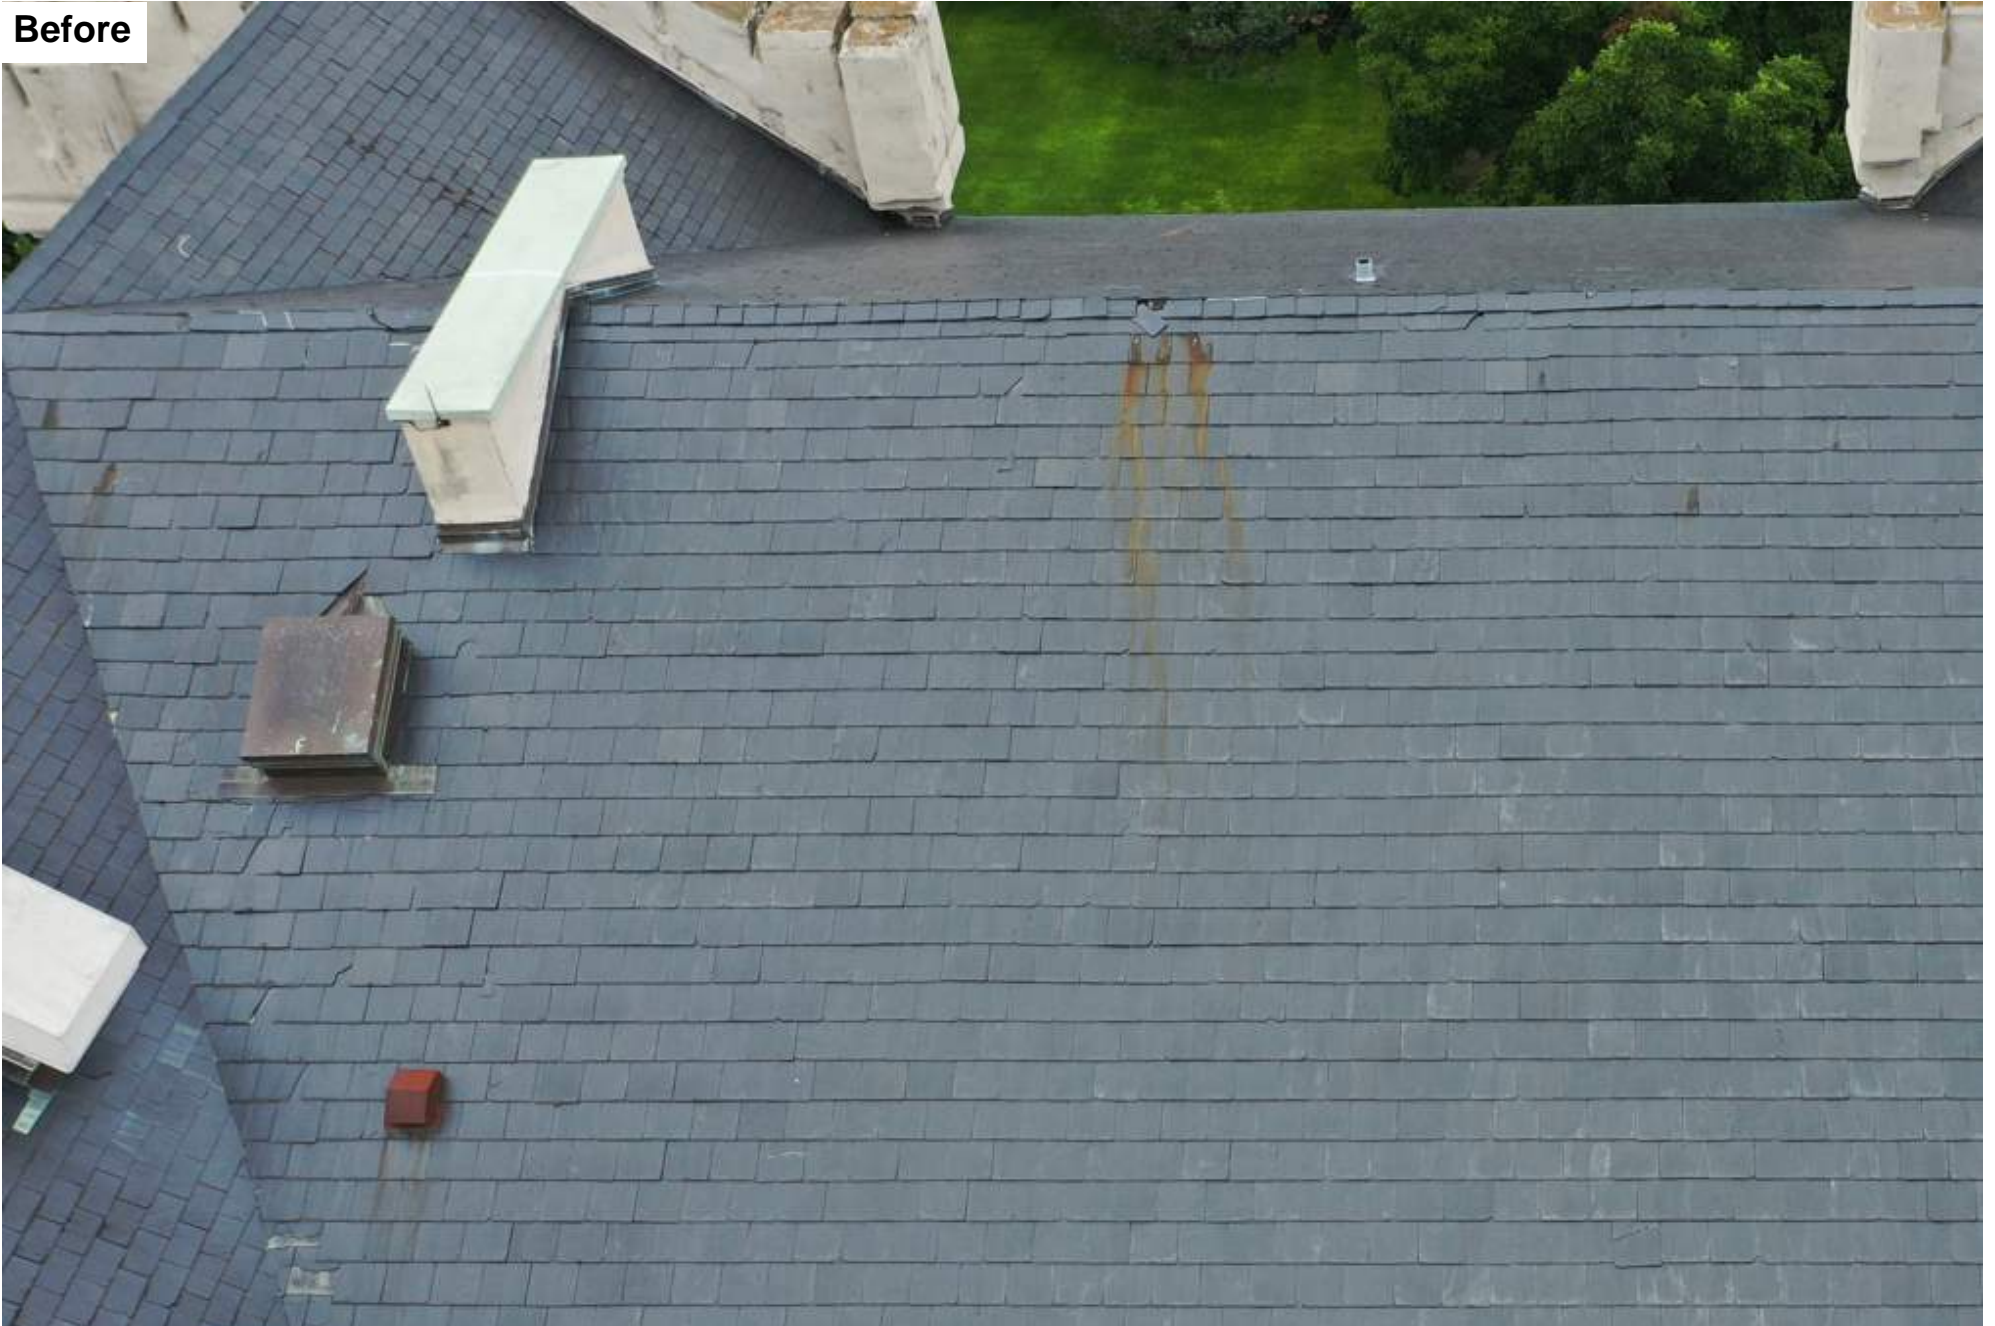
Broken, spalling, dislodged, and stained slates. Note the closed valleys cause slates to expand into each other and cause further breakage. Poor quality slate, stains and breaks easily.
