State Preservation Board

Texas Capitol Roof Replacement and Rehabilitation Update 7/31/2024

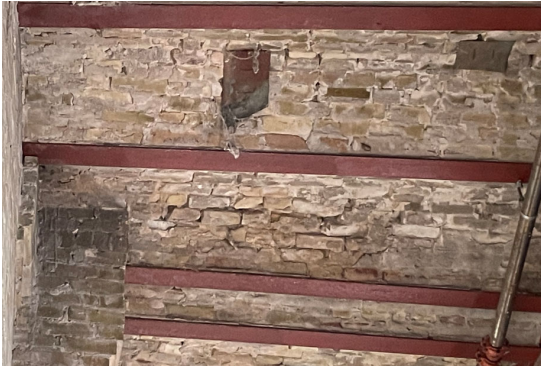
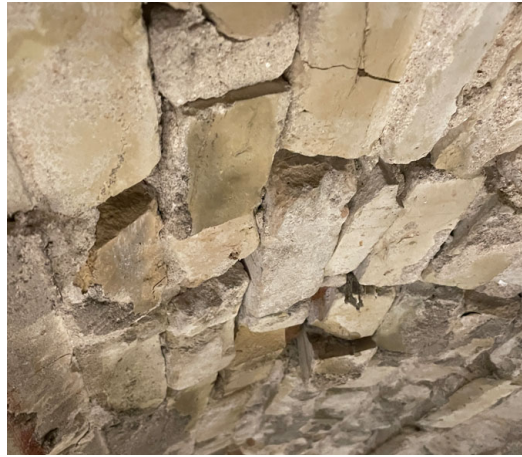
More interior dome work was completed at the center portion of the roof. Structural brick vaults were repointed for the first time in their history. These are exposed to wet and freezing conditions from the terrazzo-covered outdoor colonnade above. Many joints had lost much of their mortar, leaving bricks hanging loosely.

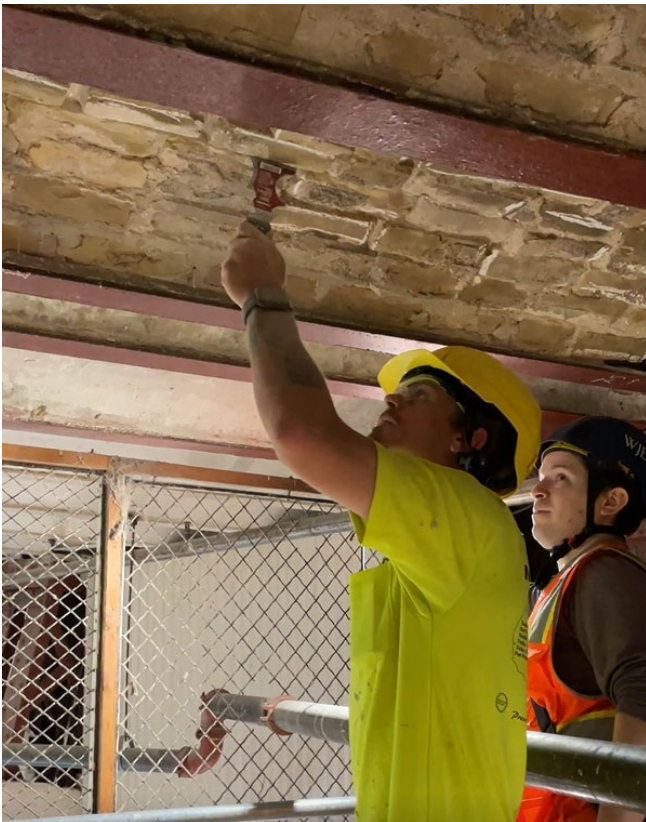
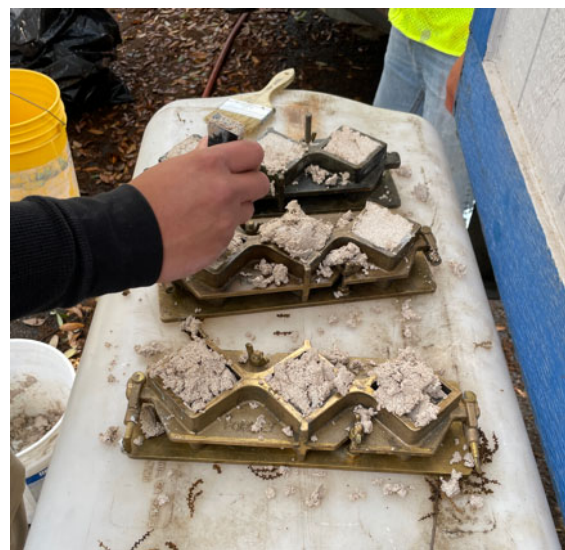
Initial mockups were approved to confirm quality of work. All mortar batches were tested for the appropriate strength for its structural purpose, while being soft enough that it doesn't grind away at the soft, low-fired brick as the building moves.

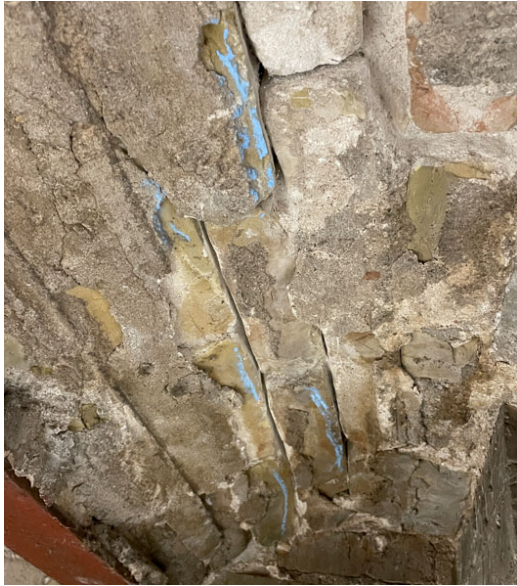
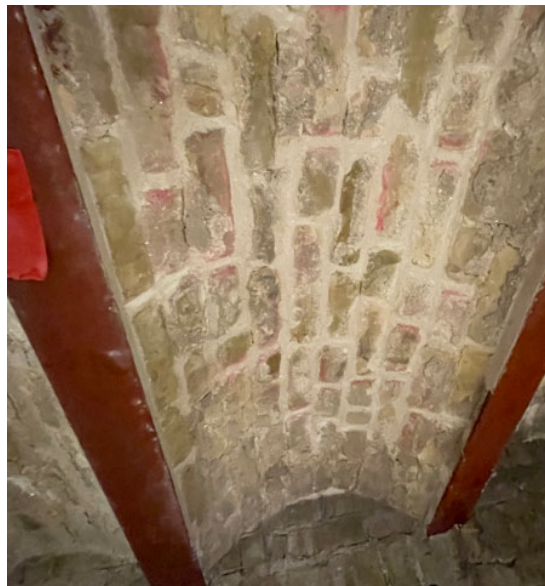
Intact mortar was left in place. All joints requiring repointing were marked, carefully raked out by hand, and repointed to match remaining mortar.

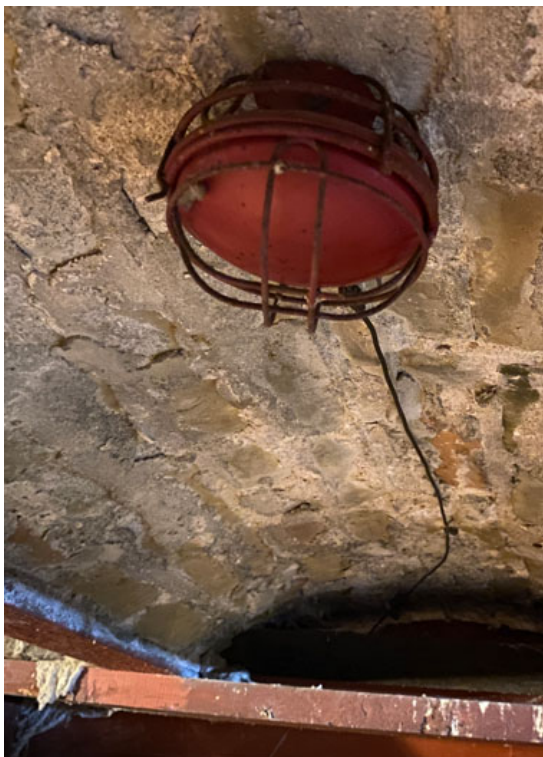
IMG_8432.JPG

The work gave us close access to remnants of a 1940's-era fire protection system which can be found throughout the historic attics. We believe these UFO-shaped, red-painted metal "pods" were kept under air pressure by small copper tubes. In case of fire, the heat would cause the pod to burst and the air to flow through. The release of pressure would signal the location of the fire at a central monitoring point, based on which branch of tube had depressurized. These were placed throughout the attics, where fires could burn undetected. They were installed shortly before the 1949 roof replacement, which would have been helpful for fire monitoring during soldering work on the wood roof deck. Today we have both modern fire detection systems and a live "fire watch" whenever soldering is occurring on the roof deck, to avoid fires such as happened recently at Versailles, during roof renovations.

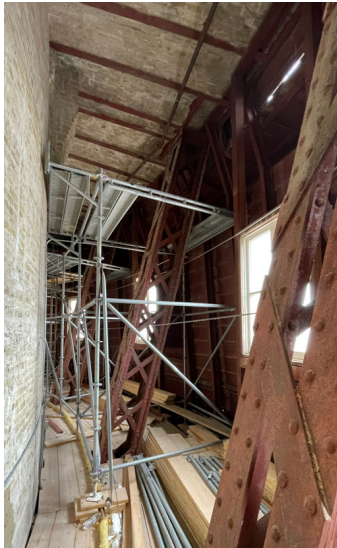
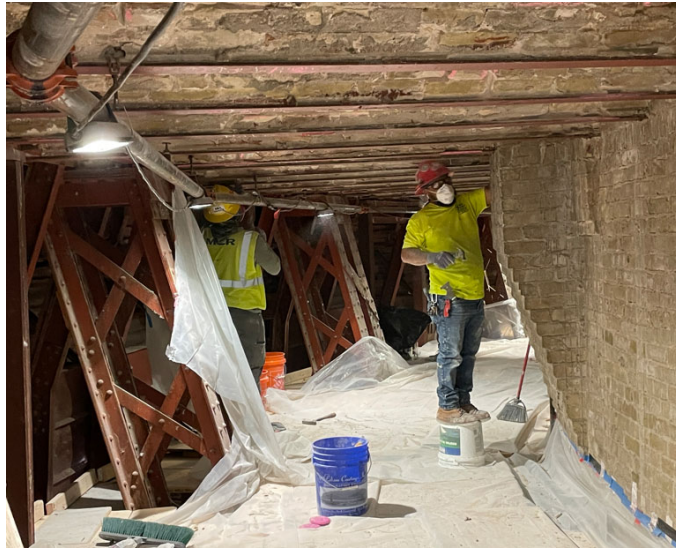
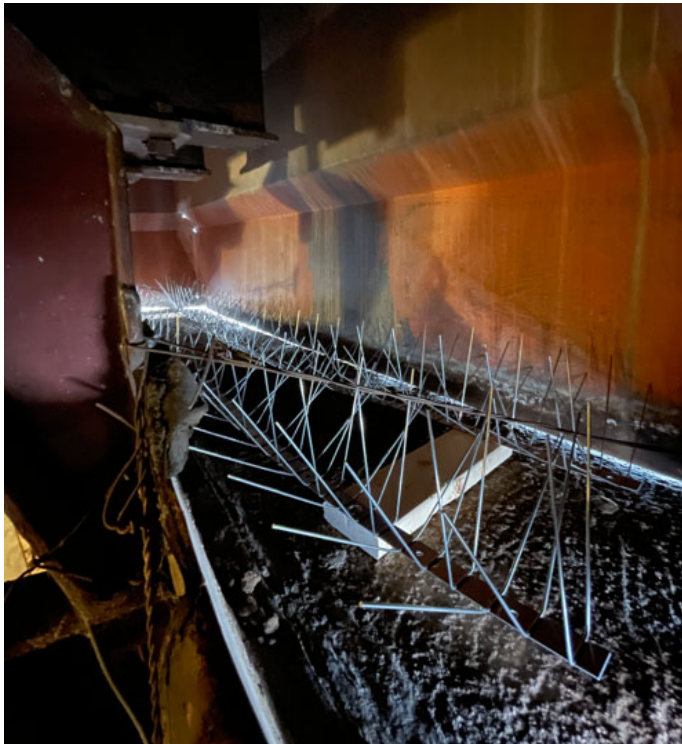
The work provided extensive access to the upper reaches of the tight, circular, tall space between the inner and outer dome. The opportunity was taken to exclude pigeons from what were discovered to be unfortunately good “nesting boxes” within the decorative metal at the upper portions of this space. After chicks had fledged, access points were blocked, the spaces cleaned, and pigeon spikes were added.

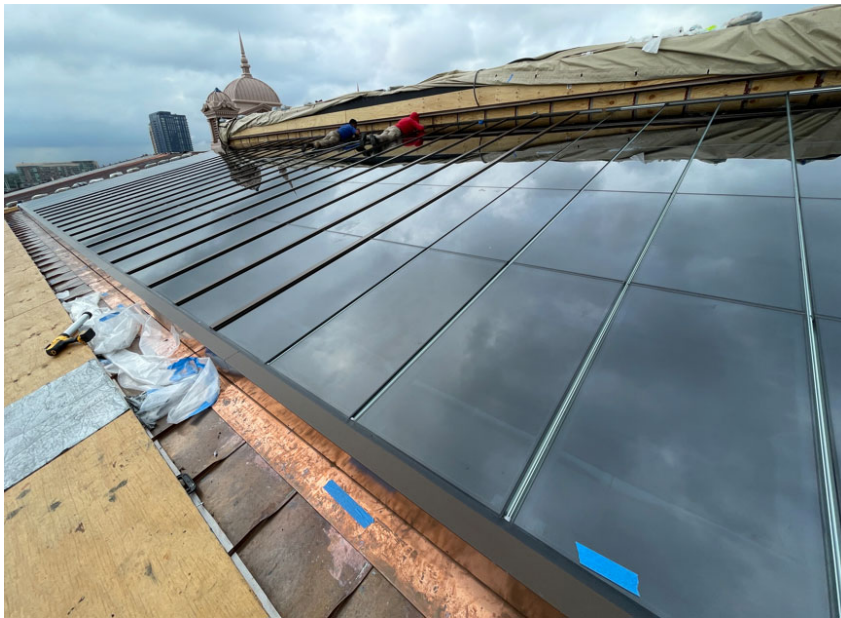
IMG_7955.JPG

The east skylight has been replaced.

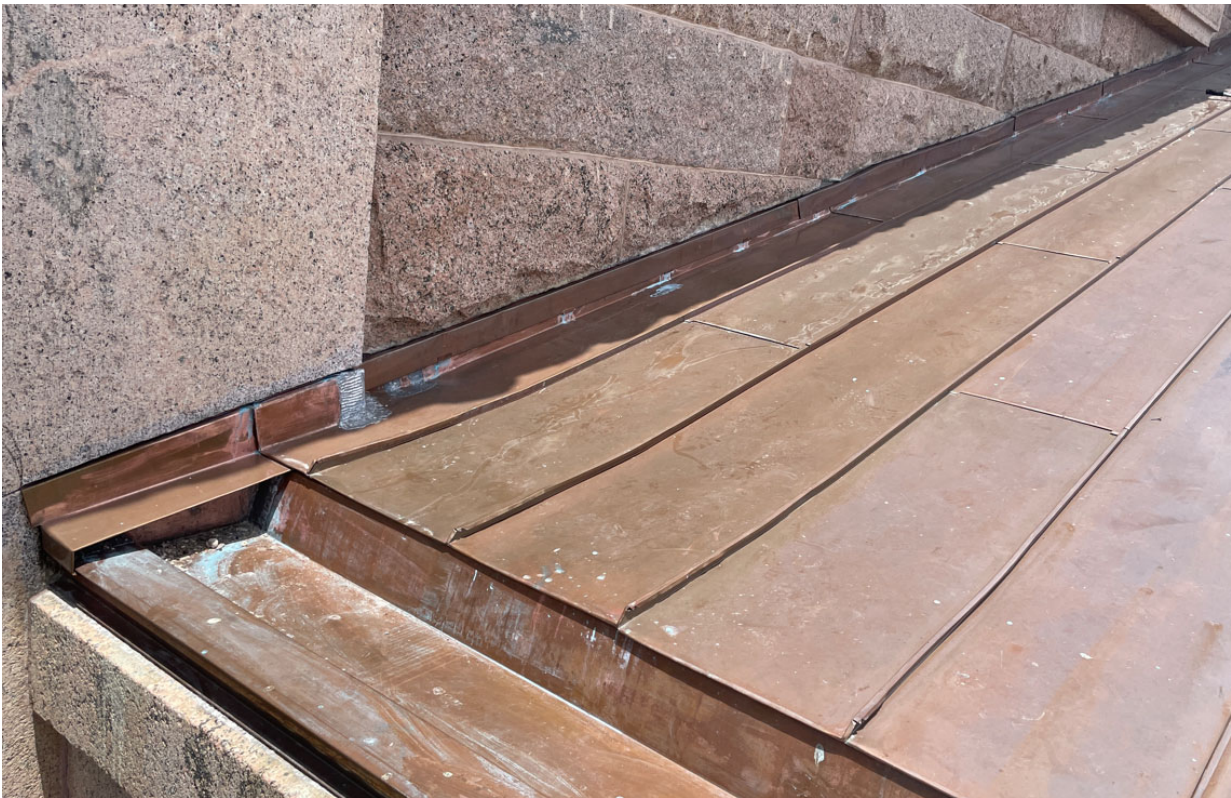
IMG_3422.JPG

Reglets have been rebuilt to provide a clean, solid connection where the roof meets historic stone walls.

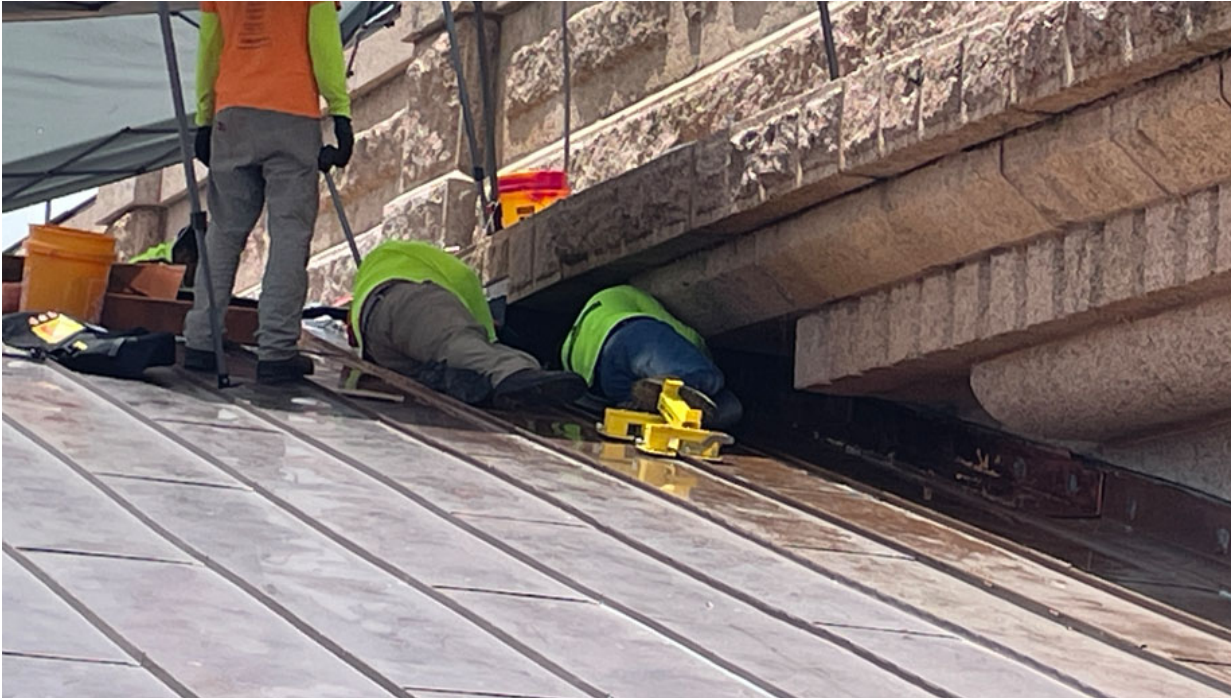
IMG_3456 (2).JPG

This includes a difficult condition where the peak of the roof hits tightly under a projecting cornice, not providing sufficient room for flashing. This is being detailed to address this condition.

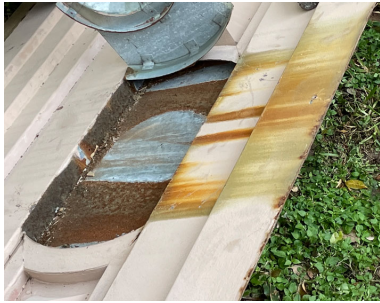
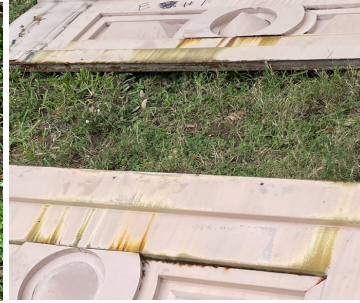
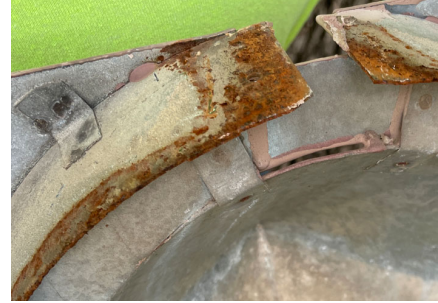
The fascia of the four corner pavilions have been a major focus of work. The decorative metal fascia had been replaced with a vent system in 1949, and was largely restored in 1993. However, the thin, shallow sheet metal construction was never fully waterproof and was a frequent source of leaks, especially in wind-blown rain.

The 1993 construction was also rusting internally and required reconstruction to stabilize.

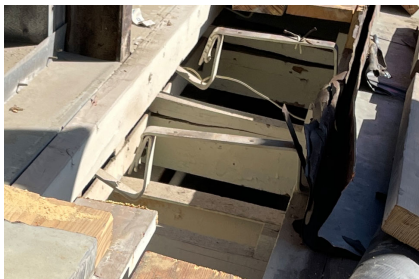
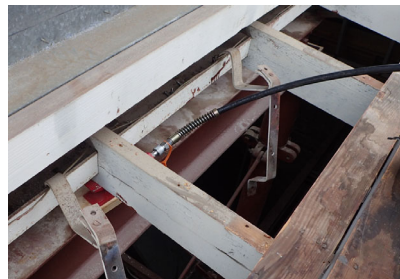
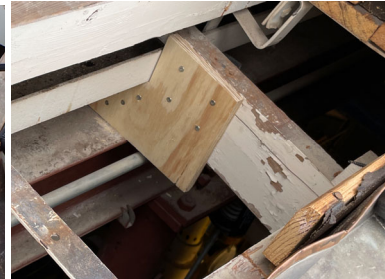
The base structure also had structural deficiencies from the original 1888 construction which led to damage over time, and required extensive repair and reinforcement.

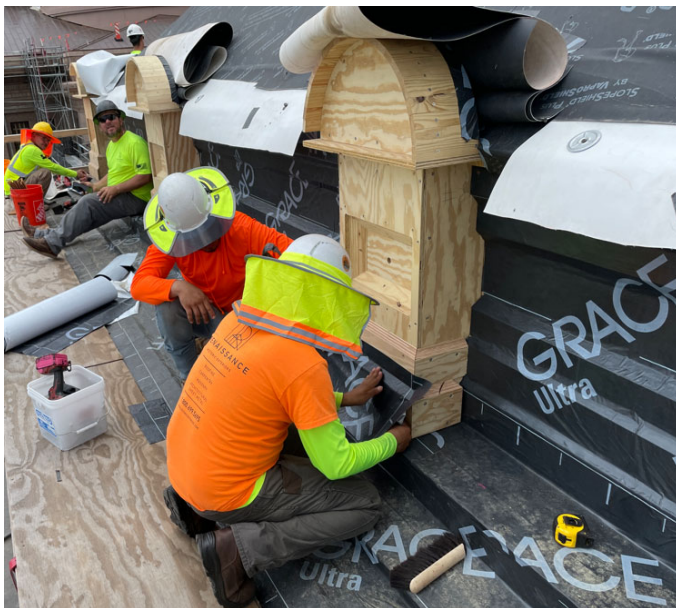
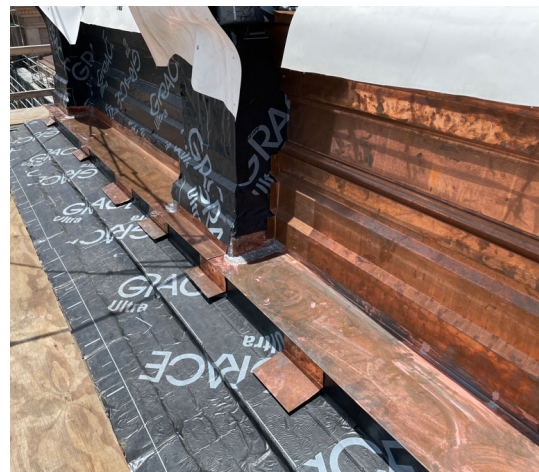
The fascia is being completely rebuilt to be stronger, solidly backed, strongly attached, and fully waterproofed for the first time in its history.
