## Capitol Exterior Deck Replacement Update - 2/20/2018

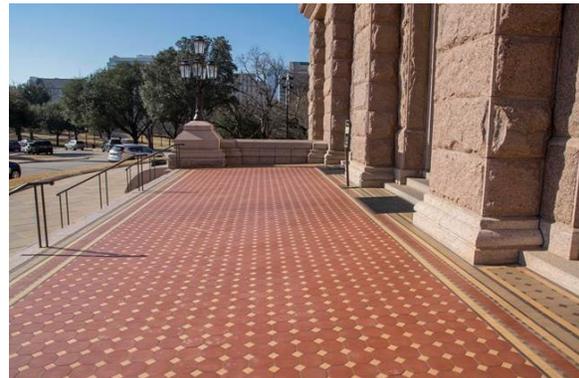
East Deck Today - 1993 era reproduction tile will be replaced, and new waterproofing installed below.

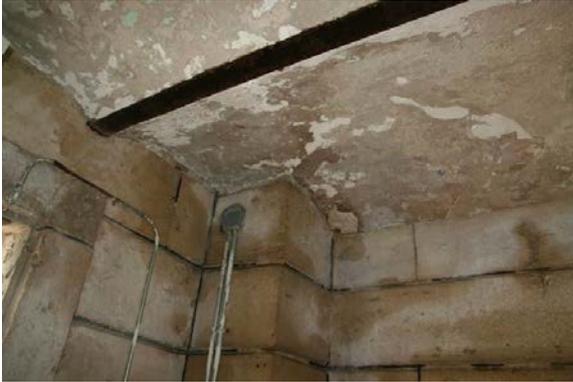
Breezeway below decks, showing impacts of water infiltration. Metal structure and masonry arches will be preserved.

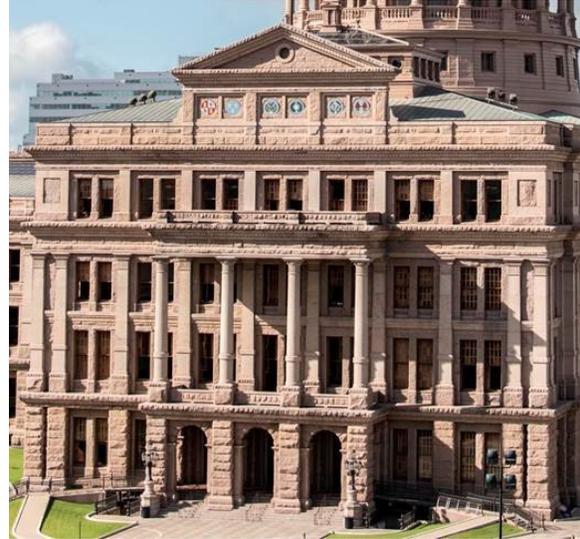
North Portico showing two elevated decks also having tile and waterproofing replaced to protect key historic metal structural elements within.
