## State Preservation Board

### Texas Capitol Roof Replacement and Rehabilitation Update 5/5/2025

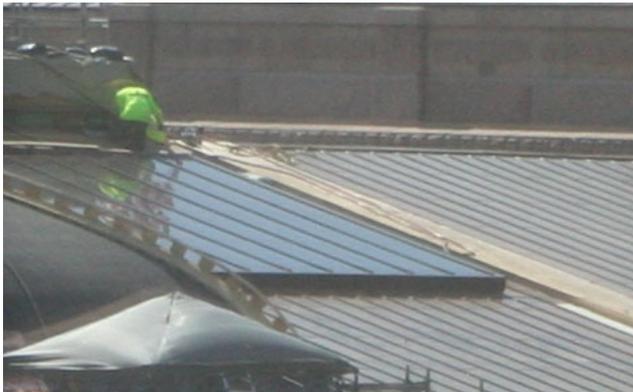
IMG\_0222.JPG

2025 skylight

Reflection of the glass was limited to 12%, well below Austin’s modern code standard of 30% and close to the historic 6%.

The new gray skylight glass provides more natural-color daylight entering the chambers below, while low-E coatings limit heat buildup in the attics. An integral UV-blocking layer protects furnishings, textiles, and artwork in the chambers below.

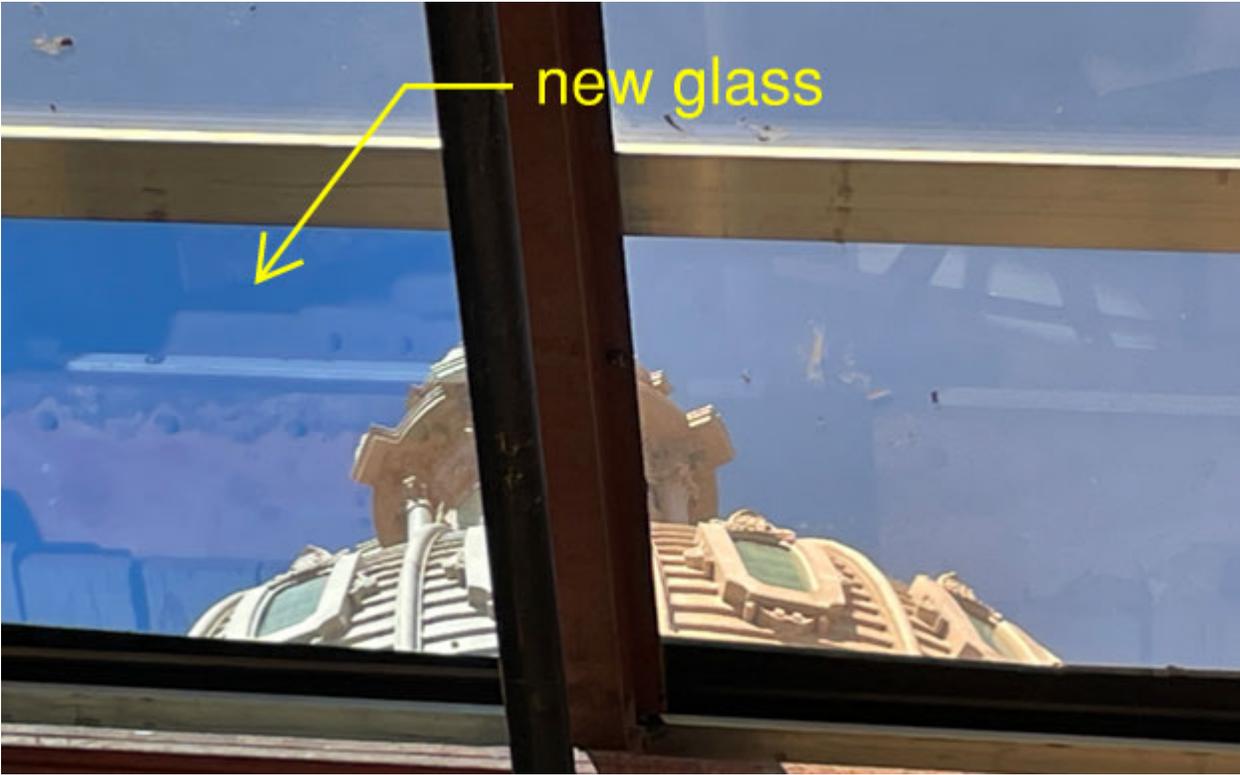
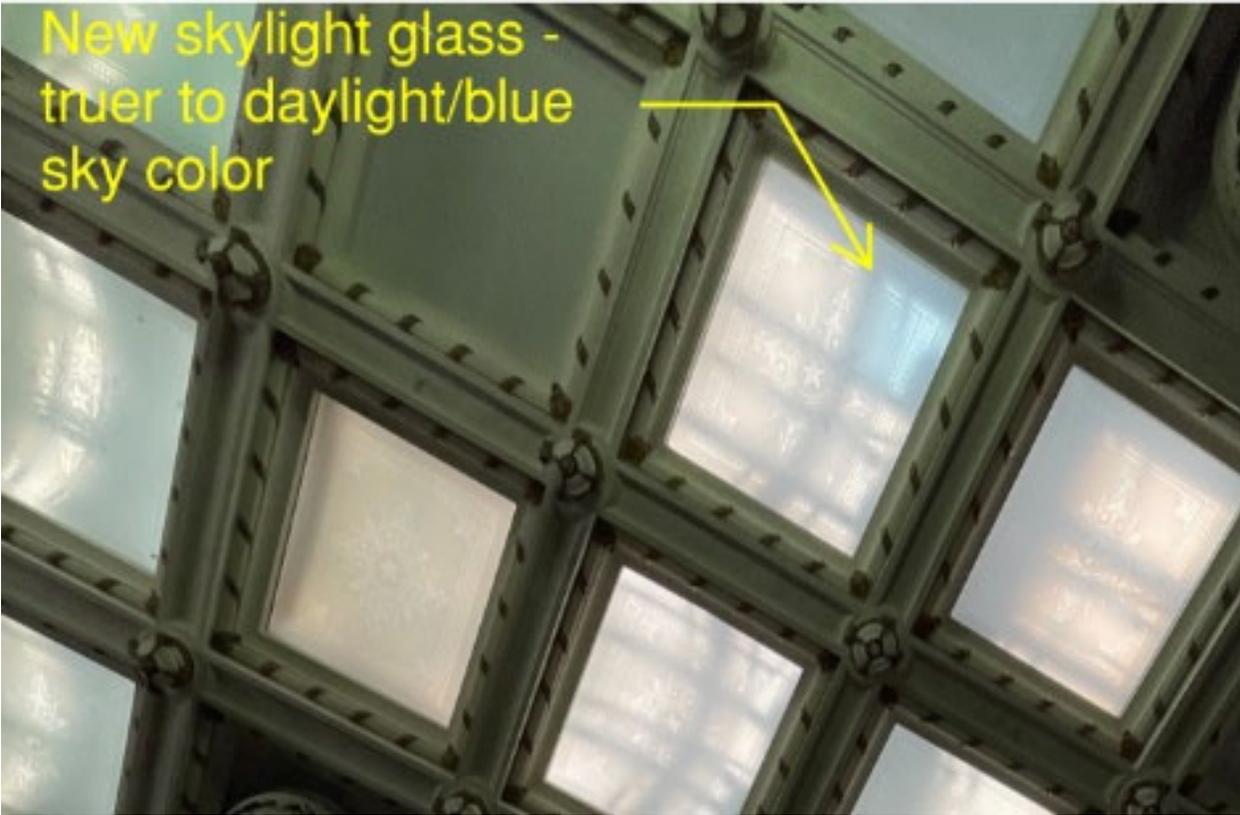
The new LED lighting system at the laylight glass chamber ceilings below the skylight replaced the circa 1995 gymnasium-style metal halide lighting, offering higher light levels, reduced maintenance and energy costs, reducing heat loads in the attic, and providing dimming and light color control to the chambers below. The transparent LED light allows through 90% of daylight and full visibility, allowing the ceiling to range from a completely original historic appearance (naturally sunlit with no artificial light except the 1890 electroliers), to fully lit to modern office standards for working conditions into the evening during late night legislative sessions.

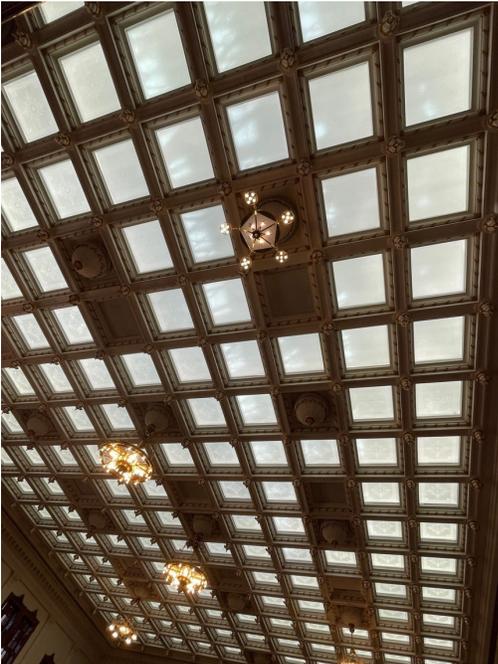
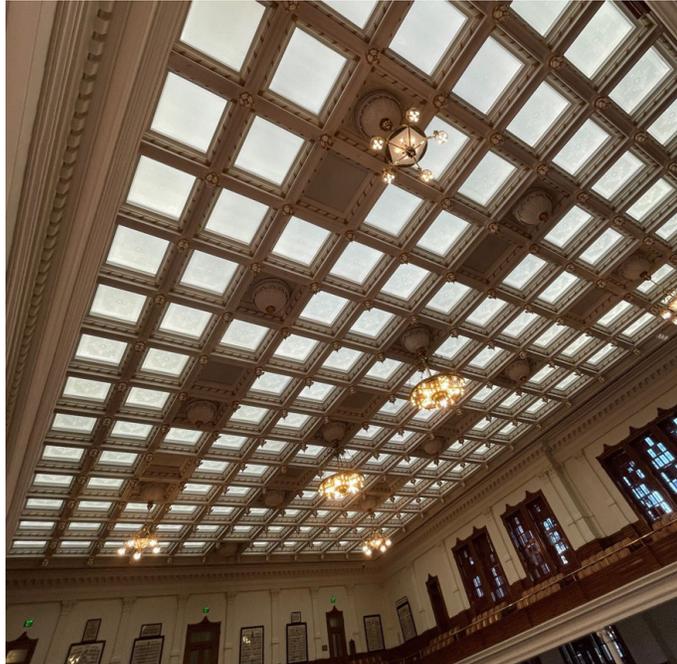
1/6/2025

New appearance on a sunny day, lights on 100%:

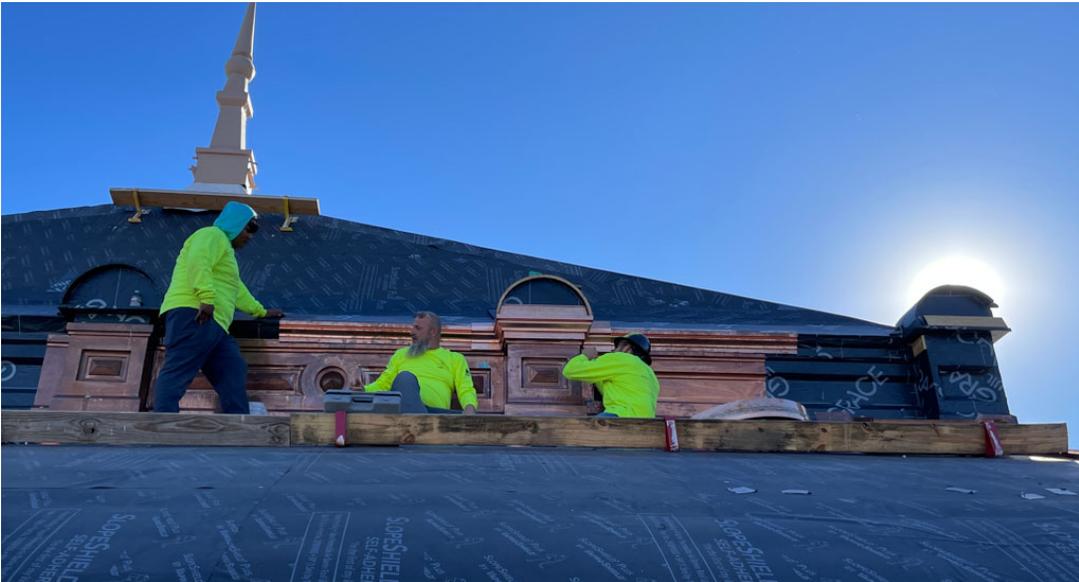
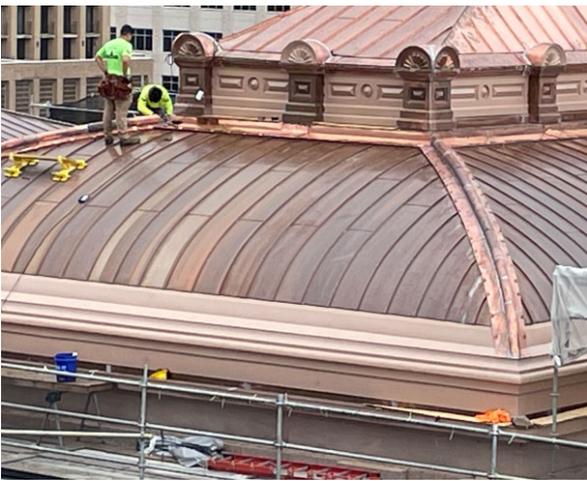
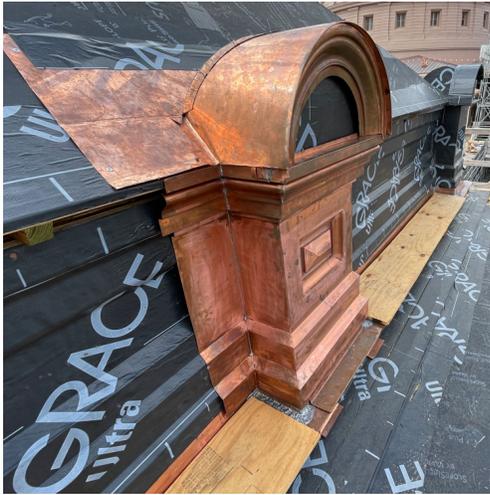
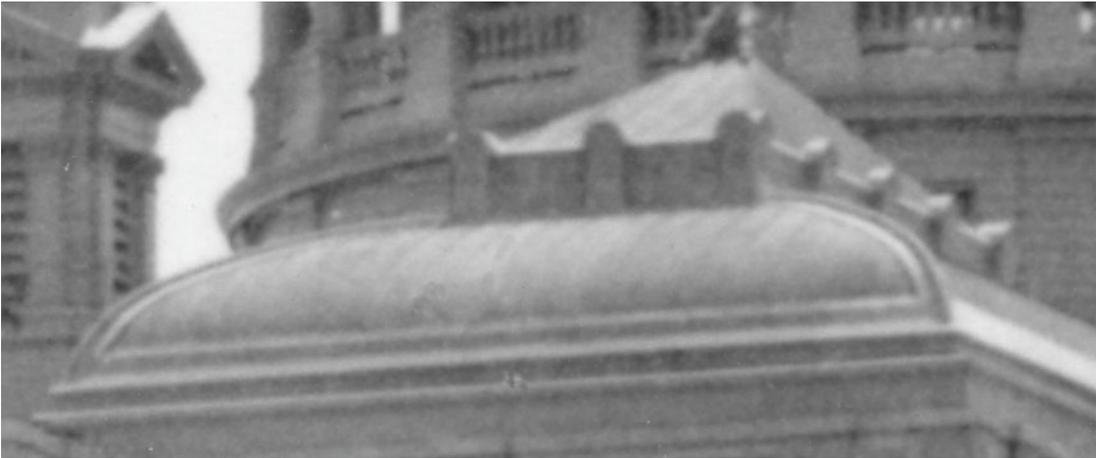
IMG\_5612.JPG

Work continues on the four corner pavilions, being rebuilt in non-corrosive copper, restoring their historic detailing, and fully waterproofing them for the first time in their history. Waterproofed wood backing was added at all decorative trim to minimize damage in hailstorms, and provide additional points of attachment to improve wind uplift resistance. While the standing seam roof may require replacement in 100-125 years, this decorative metal was designed to remain as long-lasting as the 1888 metal dome. All decorative metal will be painted to match its historic appearance, ca. 1888-1915.

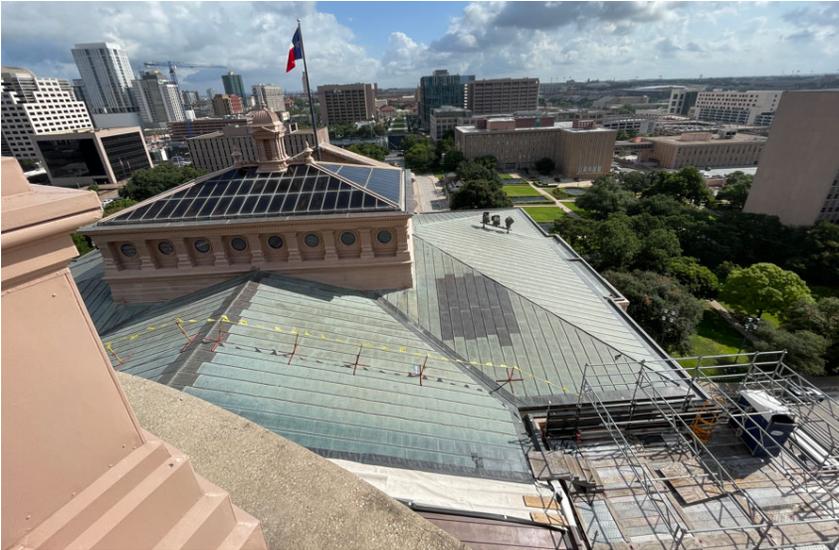
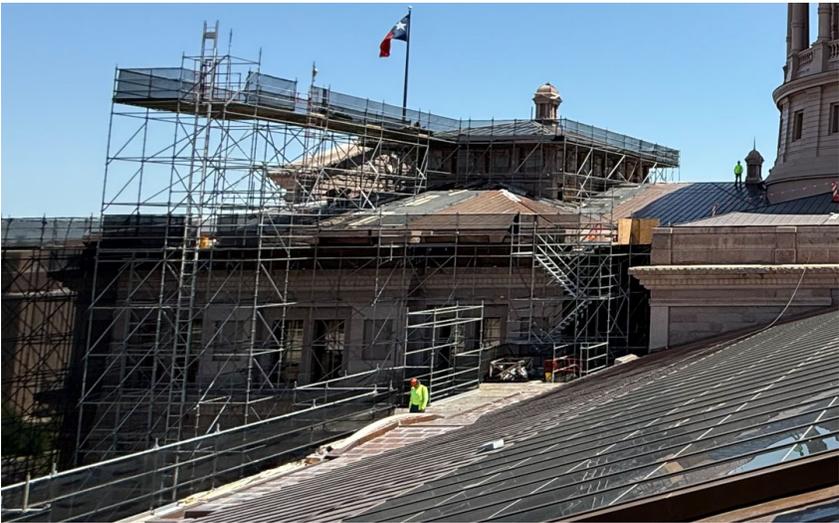
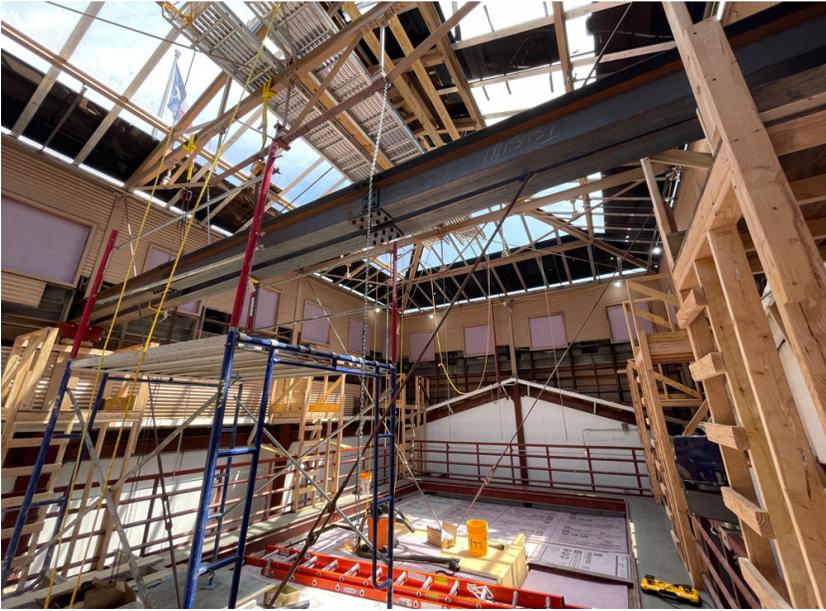
IMG\_8220.JPG

Work proceeds at the north wing, including its lantern and skylight. Load capacities of the historic iron structure made scaffolding this area for safe work a challenge.

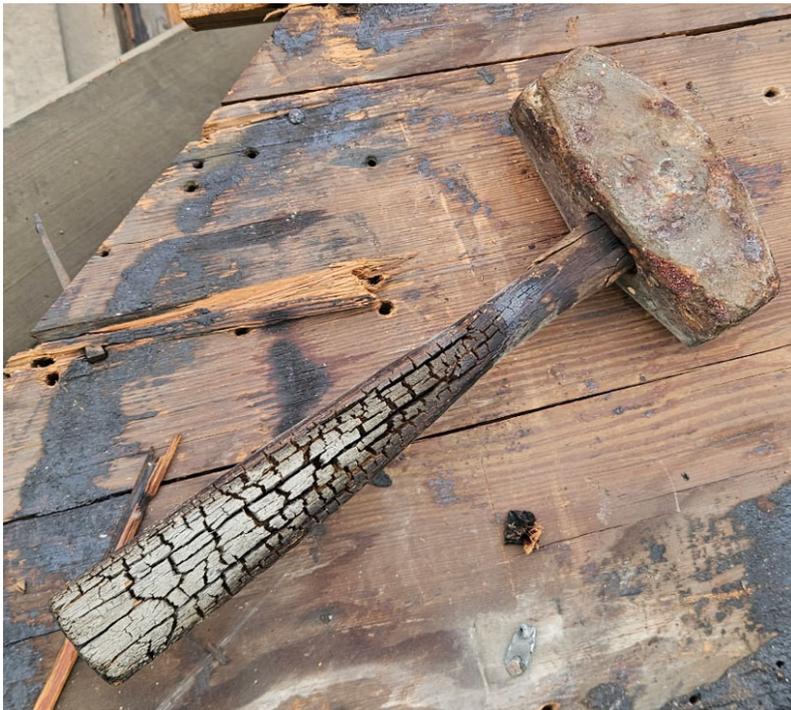
EMUM4744.JPG

In the process, opening this space for the first time since 1888, we found what we believe is a metalsmith's hammer from the original construction, likely used to fit the wrought iron straps into place, which appears to have caught fire and was abandoned in place. It will be conserved and eventually placed on display in the Capitol Visitors Center.

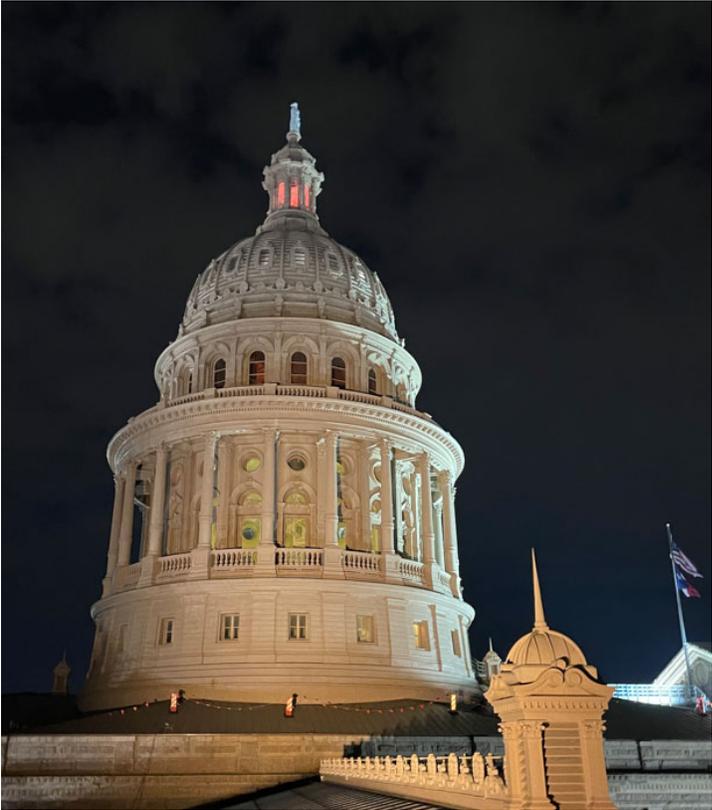
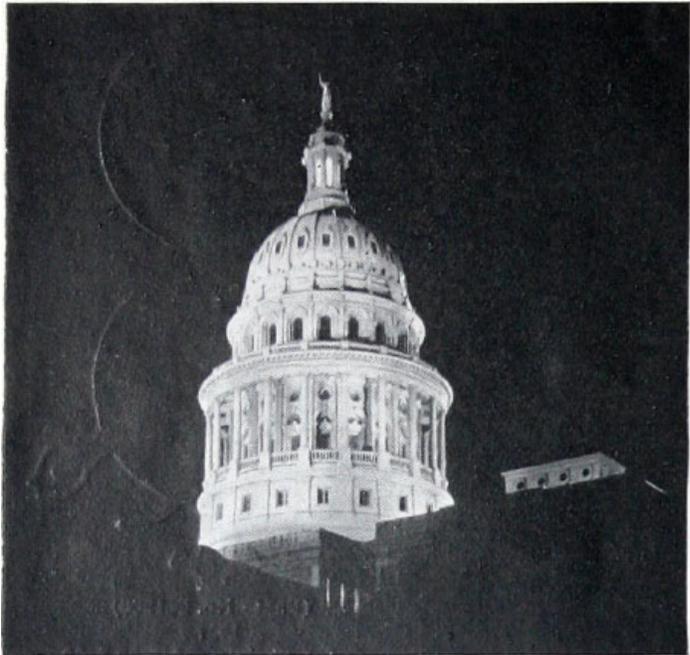
IMG\_8024.JPG

New LED dome lighting will be installed this summer, returning the dome to its fully-lit glory. Currently it is only lit from the south, and the ground. Mockups were completed to ensure even lighting, without harsh shadows, and consistent with the historic floodlight colors. Coincidentally, the LED lighting mockup was conducted close to the 100<sup>th</sup> anniversary of the dome's first floodlighting with Novalux incandescent floodlights in February, 1925.

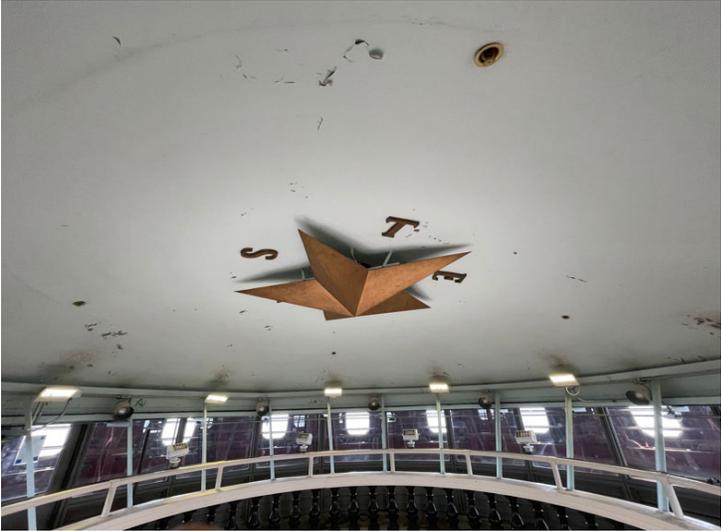
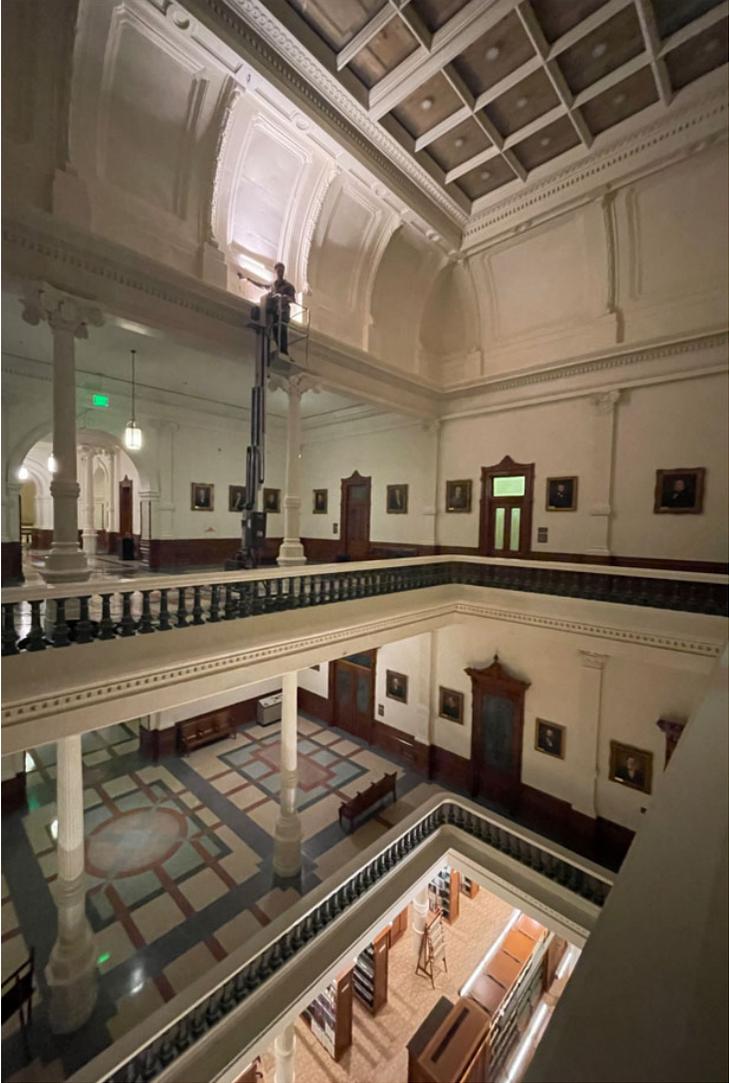
IMG\_2327.JPG

Scaffolding inside the building will be required this summer for repainting of the diaphragm above the oculus 218 feet above the rotunda floor, and installation of uplighting at the north atrium ceiling coffers, consistent with the light treatment in the rotunda. This will allow removal of lighting above the north atrium laylight ceiling, restoring it to its historic appearance. Scaffolding for both will be a challenge.
