Texas Capitol Roof Replacement and Rehabilitation

Project Update, 1/20/2023

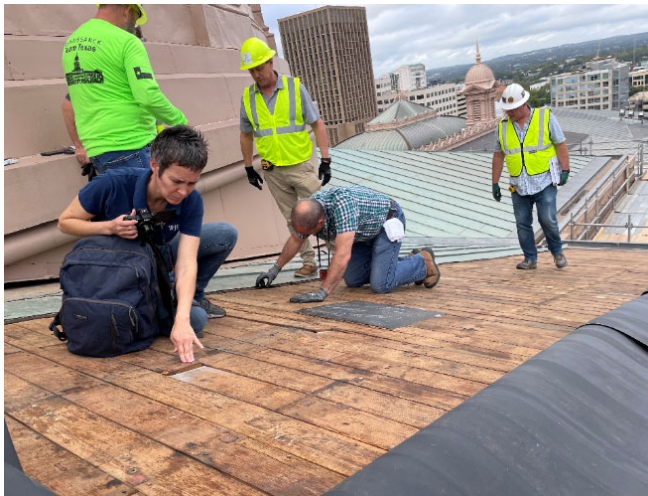
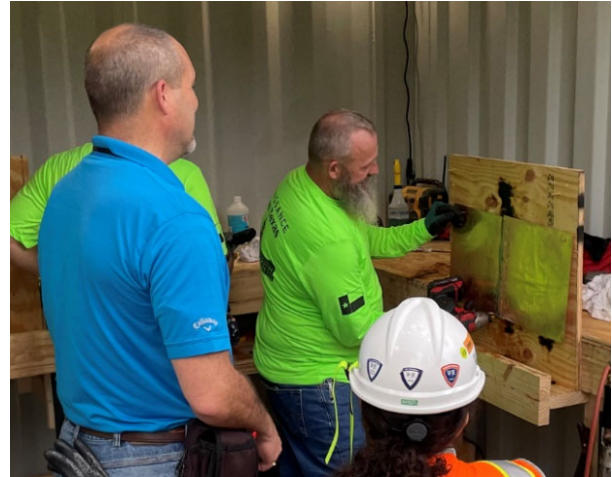
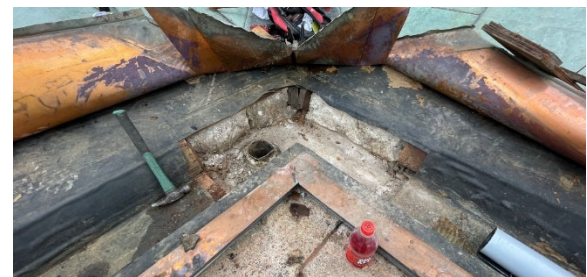
On the roof, through November and December, technicians were certified to ensure they can properly solder copper seams, exploratory openings were made at the roof deck and gutters to examine underlying conditions, and mockups of design details were constructed for review.
