State Preservation Board

Texas Capitol Roof Replacement and Rehabilitation Update 12/13/2023

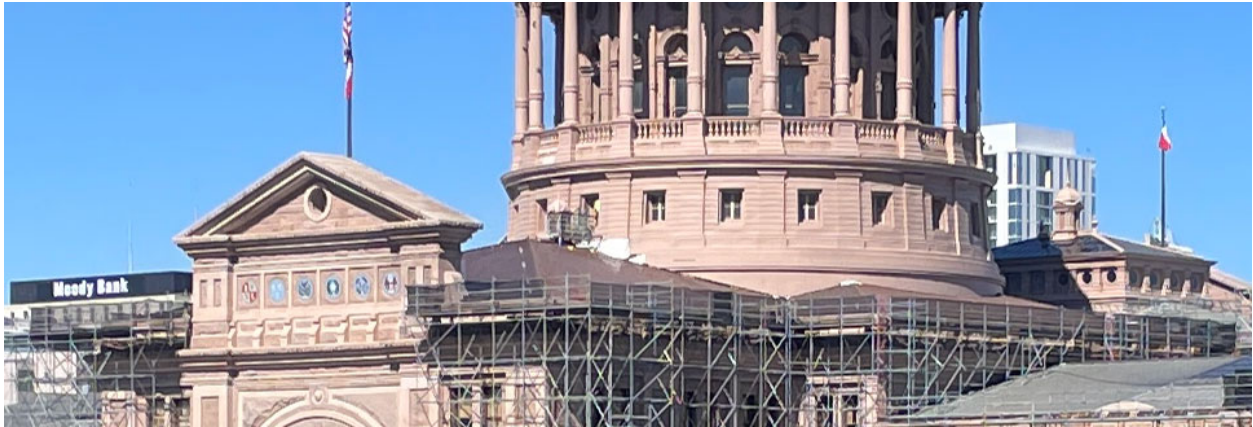
The south wing and area around the dome is complete, scaffolding will begin coming down soon.

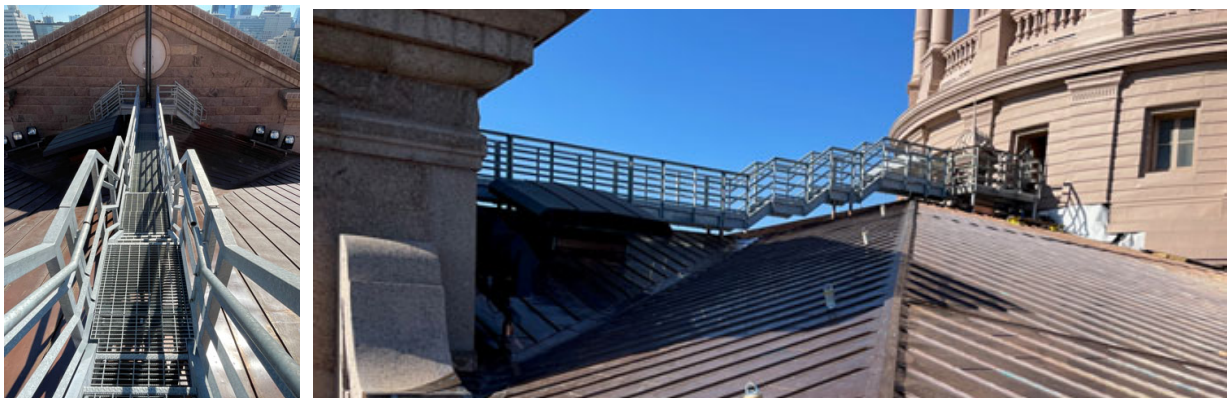
It will have steps, rather than a ramp like the previous catwalk, for OSHA-compliant access for personnel flying flags. It will also provide safe access to the roof surface.
