Old General Land Office Building/Capitol Visitors Center

Exterior Preservation and Roof Replacement

Project Update: 9-18-2023

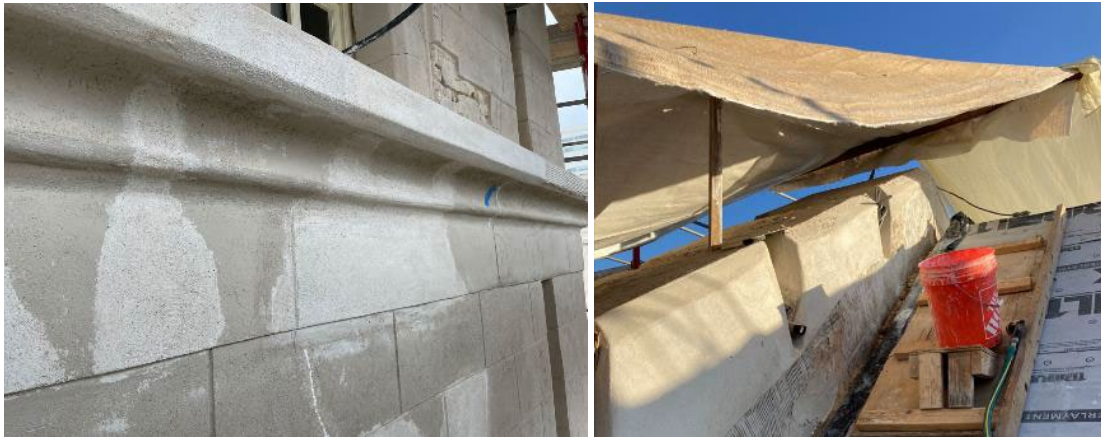
We have encountered a variety of different unique conditions on the building including severe mortar loss in the historic limestone walls, random bricks/dirt/rubble near exterior face, and even exposed timbers just $\frac{3}{4}$ " shy of the outside wall. We've found large 1'-2' voids in the 3' thick walls that were filled with large quantities of black dirt. We think this was a historic black clay used as a binder along with mortar during the original construction.

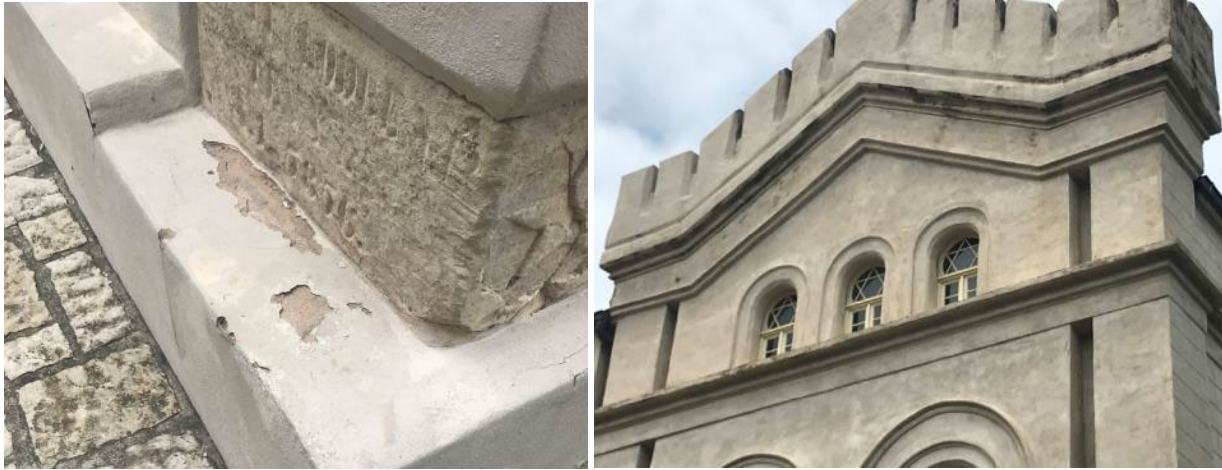
The existing paint had to be stripped wherever it was loose on the building and also be pressure washed before testing any new coatings.

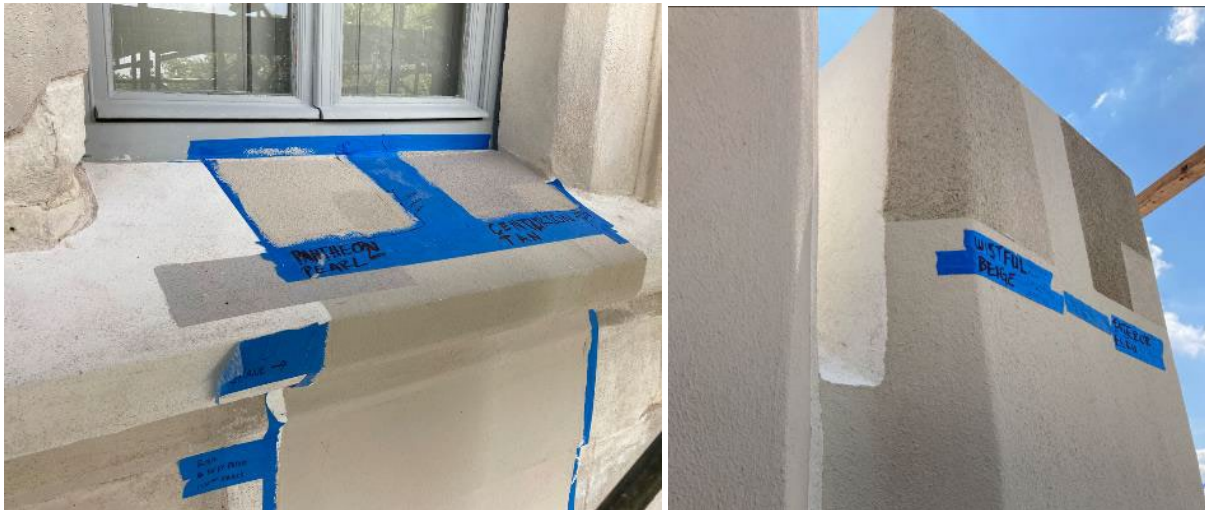
Extensive testing has been completed to select the best coating, with the need to provide durability, breathability, and colorfastness, while being applied over remaining paints and repairs.

Acrylic, silicon emulsion, and mineral based were tested on vertical surfaces.

Flat projecting surfaces with high exposure to weather were tested with elastomeric, cementitious acrylic emulsion, and silane water repellants.

We tested all of the products on the various conditions in locations depicted in the drawing below and ultimately went with a mineral based paint for its high performance, breathability, colorfastness, and complementary material makeup for stucco/stone applications. The mineral-based paint also allows for an endless number of future preservation maintenance paint coatings.

We decided to use a highly durable and impact/uv resistant elastideck on the projecting horizontal courses at each floor and the skyward facing surfaces of the character defining crenellations, to protect against rainfall, running water and hail, in these locations which had shown the most stucco deterioration since the 1993 building restoration.

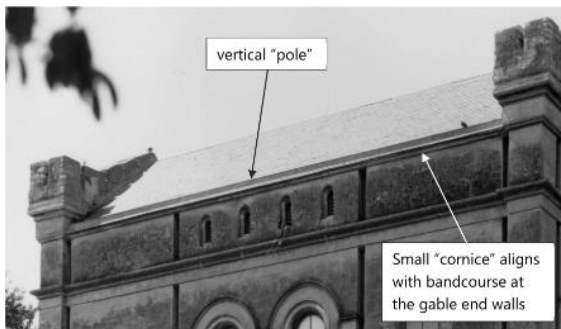
The roofing consultant has historic experience and was able to uncover lost architectural features from historic photographs from the 1870's and 1880's. There was originally a pole gutter design used on the building during its period of significance between 1880 and 1920. This type of gutter is more common in Europe and the northeast United States. The pole gutter is essentially a gutter that sits on top of the roof near the lowest point, unlike a hanging gutter which is mounted to the top of the façade near the base of the roof. The pole gutter design also allowed us to recover a lost stucco projecting band that wrapped the façade like a hat. Although it's a small detail it will be one more step further into properly restoring and interpreting the building to its 1880's period of significance.

1920s historic photograph before the addition of the hanging gutter.
