State Preservation Board

Texas Capitol Roof Replacement and Rehabilitation Update 7/31/2024

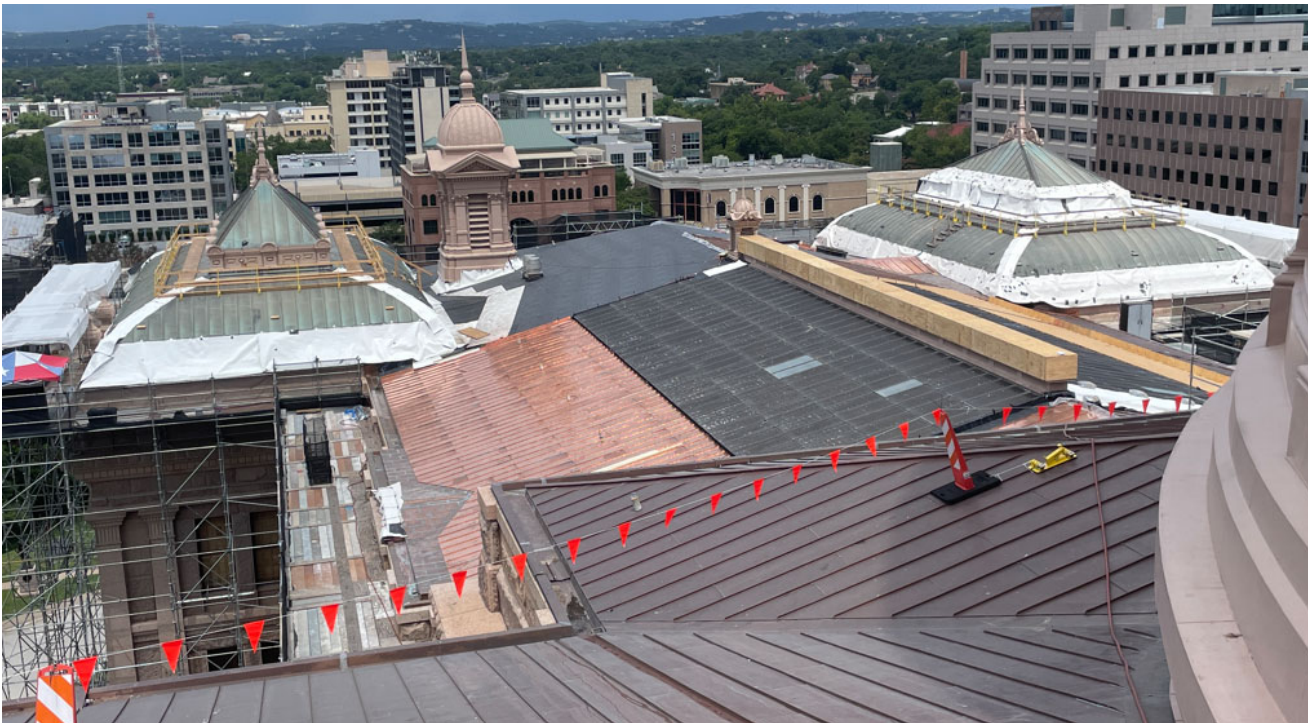
IMG_3409.JPG

Roof work proceeds on the east wing and the west wings, including their skylights and corner pavilions.

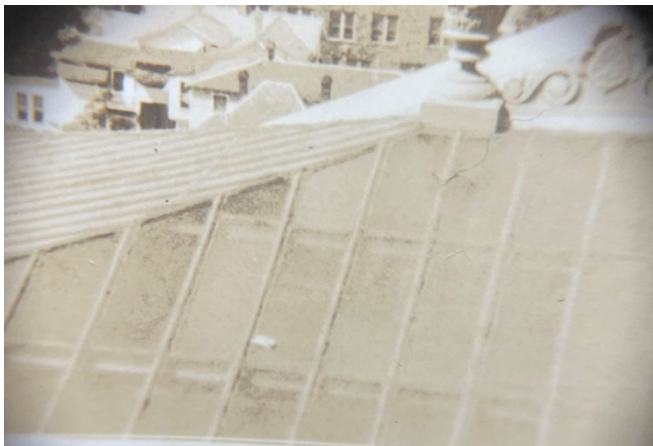
The patterns of vertical batters on the new skylight closely match the original, historic skylight.

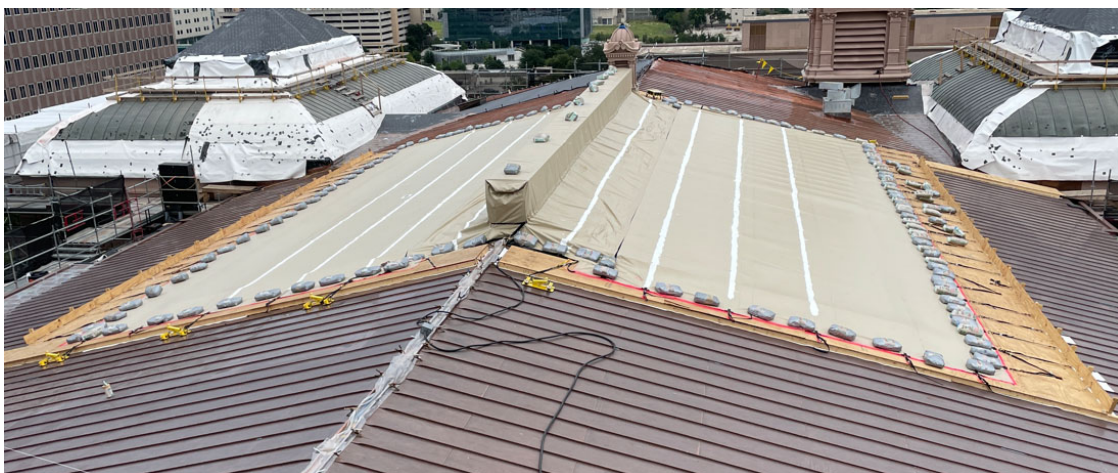
IMG_6071.JPG

During work, the opening in the roof was protected with a tarp custom designed to withstand winds of at least 100 miles per hour.

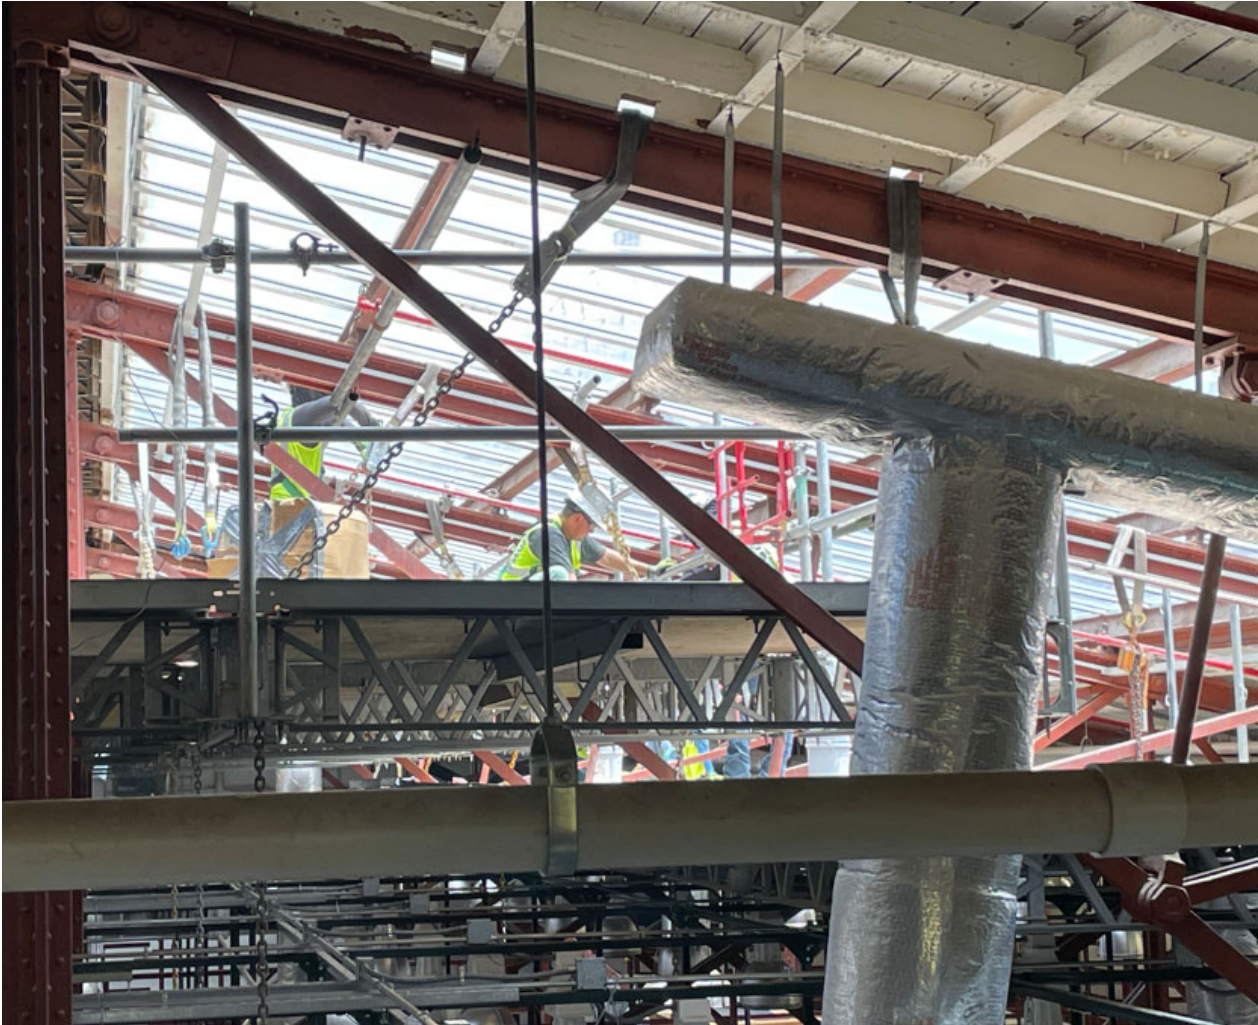
IMG_5987.JPG

Access to the skylight from below was achieved with a scaffolding system hung from chains, designed for work under bridges. All point loads on the historic wrought iron structure were carefully considered.

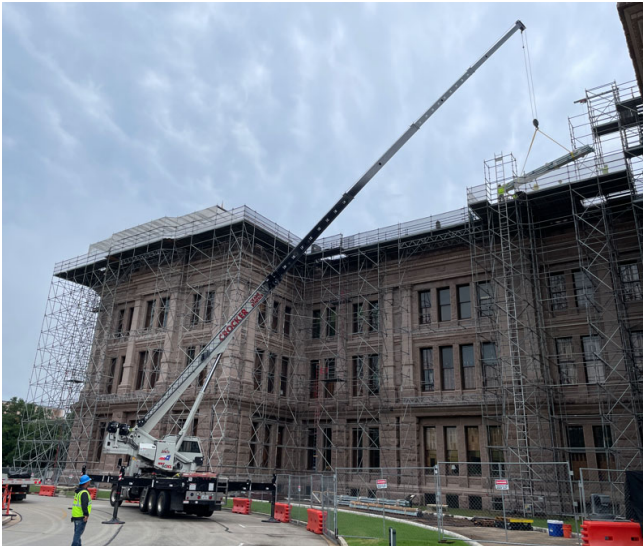
IMG_2591.JPG

New glass and framing was flown to the roof with a crane.

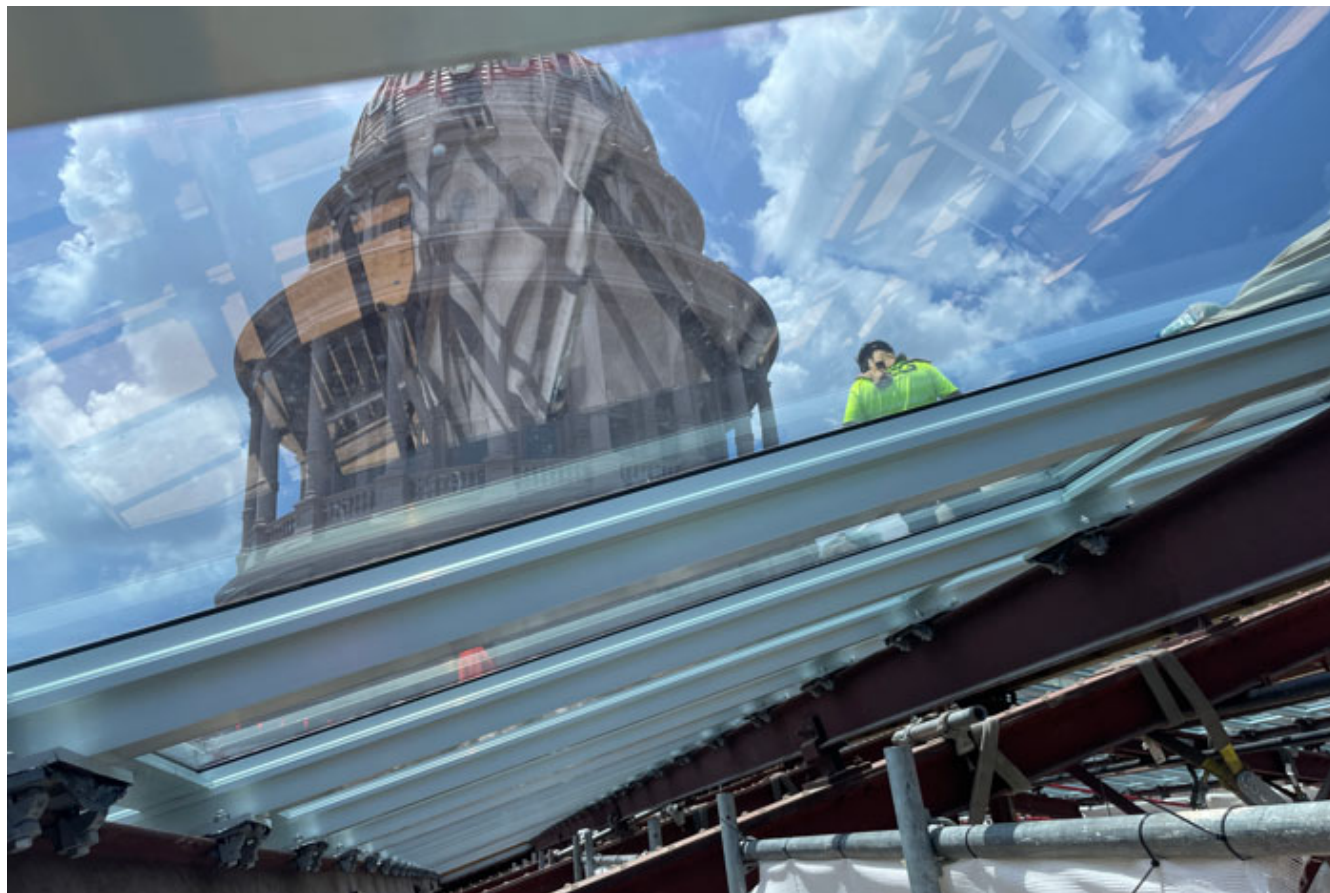
IMG_3364.JPG

The new glass is tinted grey instead of the bronze color which has existed since 1949, to provide a more natural color sunlight to the chambers below...the original glass would have been clear. It has UV blocking and a low-e coatings, balancing the goal of maximum visible sunlight for the historic chambers below, while protecting furniture and art below from harmful UV rays and providing energy efficiency by limiting heat gain in the attics.

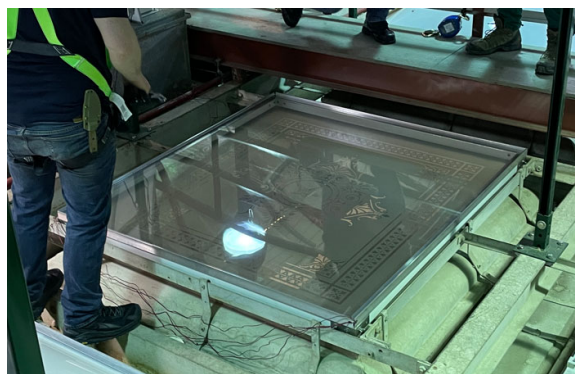
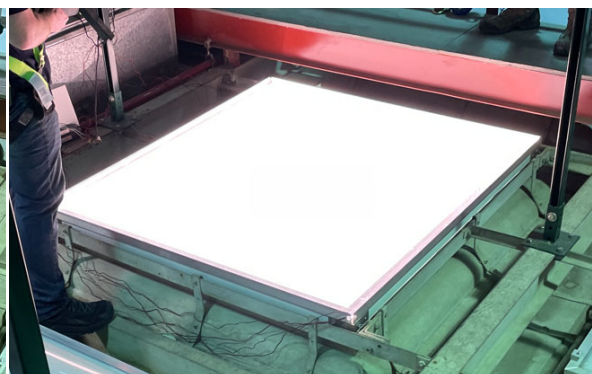
The new LED lighting system will begin to be installed soon at the glass laylights in the chamber ceiling below the skylight. It uses side-lit panels which are completely transparent, allowing them to supplement natural light from the skylights above without impacting the historic appearance of the transparent glass laylight ceiling from the chambers below. It will provide long-needed light for late evening work during legislative sessions, and a full range of color and intensity controls. It replaces a metal halide lighting system installed in 1993. It will save energy, maintenance costs, and reduce heat loads in the attics.

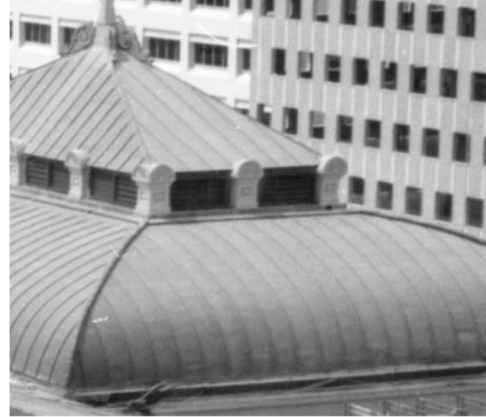
1949 vent system:

The fascia of the four corner pavilions have been a major focus of work. The decorative metal fascia had been replaced with a vent system in 1949, and was largely restored in 1993. However, the thin, shallow sheet metal construction was never fully waterproof and was a frequent source of leaks, especially in wind-blown rain.

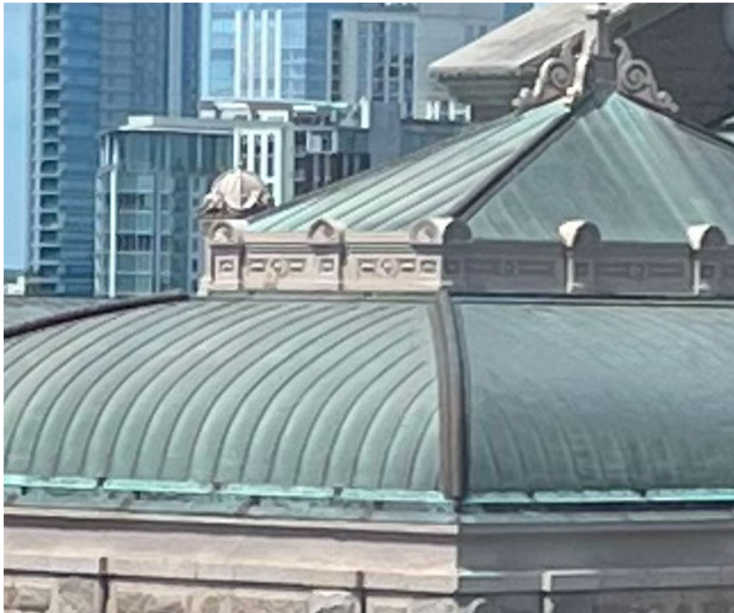
1993 reconstruction of historic profile:

The 1993 construction was also rusting internally and required reconstruction to stabilize.

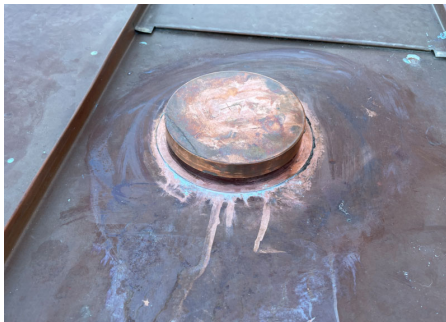
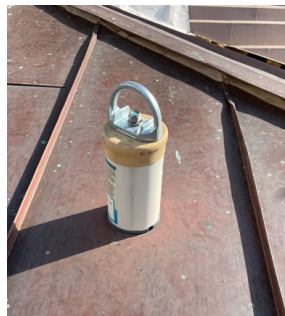
The fall protection system will receive its decorative caps soon, hiding the mounting points for the tie-off devices, which can be deployed as needed without impacting the historic appearance of the roof.

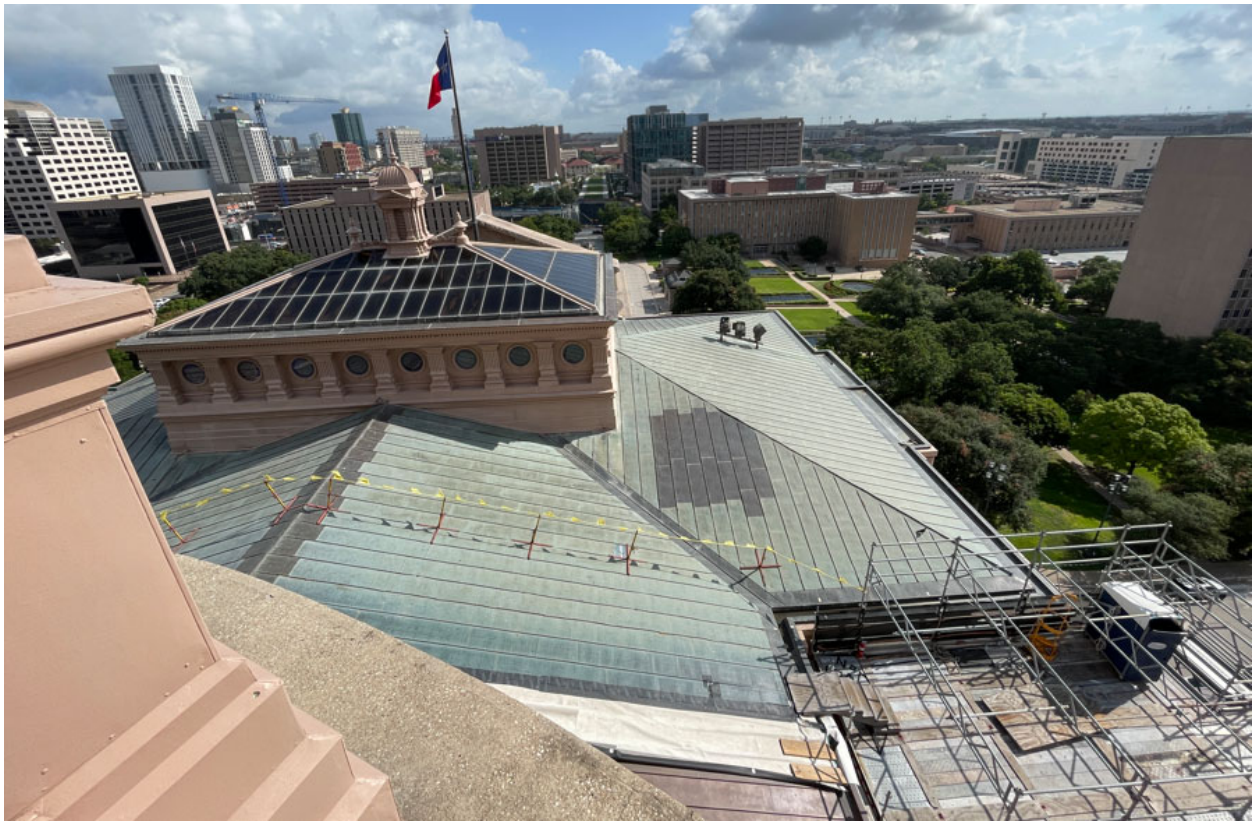
IMG_8220.JPG

In the fall, work will begin on the final phase of the project, the north wing and its skylight.
