## Capitol Exterior Deck Replacement Update - 2/20/2018

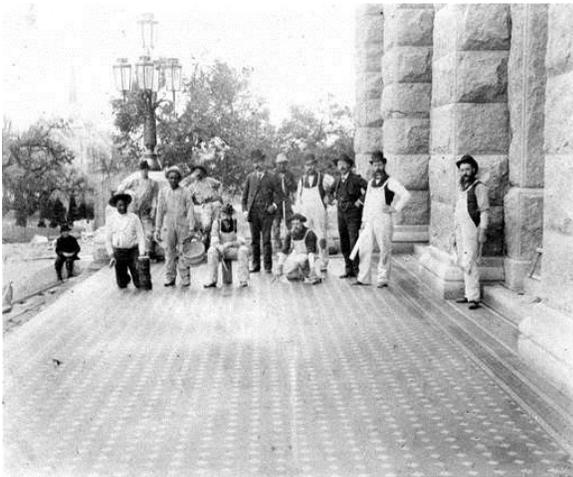
East Deck Installation - c. 1888. Courtesy The Dolph Briscoe Center for American History, The University of Texas at Austin.
