Exterior Door Preservation Project August-November 2018

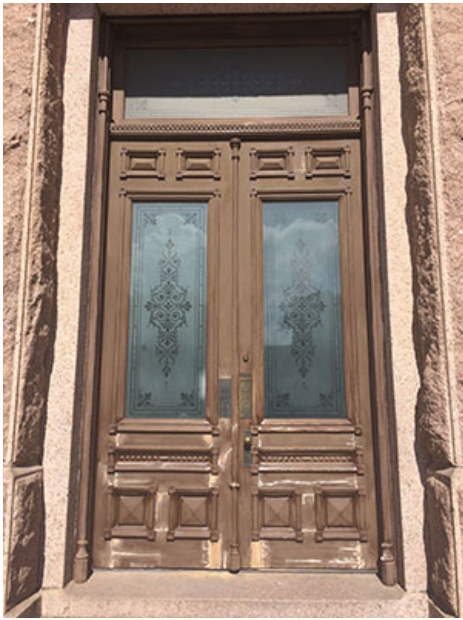
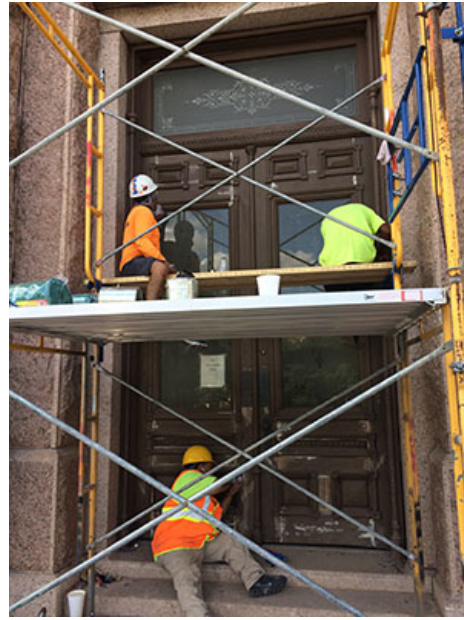
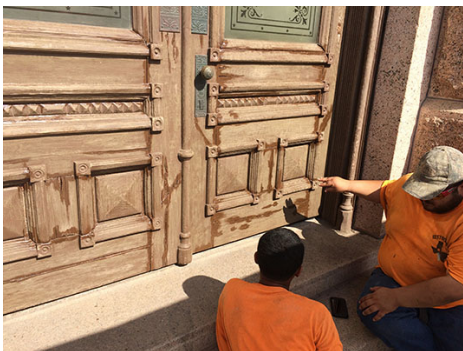
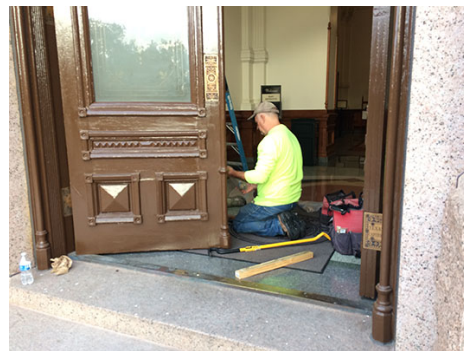
The exterior doors that greet visitors to the Capitol are original 1888 construction. In addition to facing sun, rain, and wind for the past 130 years, they are currently used by more than 1 million visitors per year. Built of a thick layer of oak laminated over a core of white pine, the doors are hung on the largest of the massive "Texas Capitol" hinges found throughout the building.

This year, the SPB conducted a preservation effort on these important historic elements. The sensitive treatment included stripping loose paint, patching cracks and nicks, replacing perimeter sealants, and applying a fresh coat of protective paint to the exterior. Sweeps were replaced at the bottoms of the doors to keep out air and insects. New closers were installed to make these massive doors as easy as possible to open, while keeping them securely shut to keep out the elements. All historic hardware was restored to smooth function. Attachment points of hardware were reinforced to protect adjacent historic wood, and catches were adjusted to accommodate each door's unique shape without placing them under stress.
